**CARBON SIX
LETTINGS**

Sample Check In Report

123 Sample Road
City
Postcode

Company	C6 Lettings
Date of Inspection	24/02/2021
Prepared by	C6 Lettings
Inspected By	Mr. Inspector
Agent	Ms. Agent
Adults	2

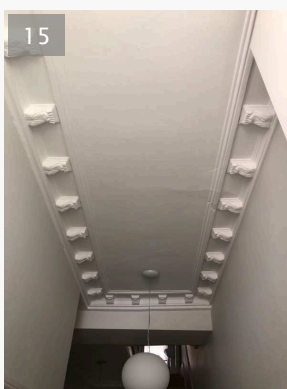
Some visible unevenness and cracking in the ceiling, appears previous repairs have been made.

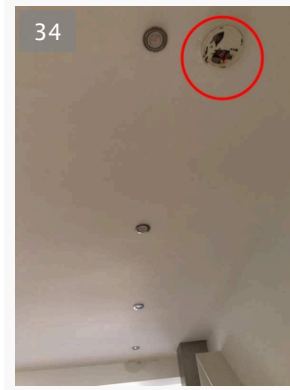
[Photo 34] missing smoke detector

missing smoke detector
24/02/2021 12:39 (GMT)
at 51.57146214504197°, -0.1297999355482516°

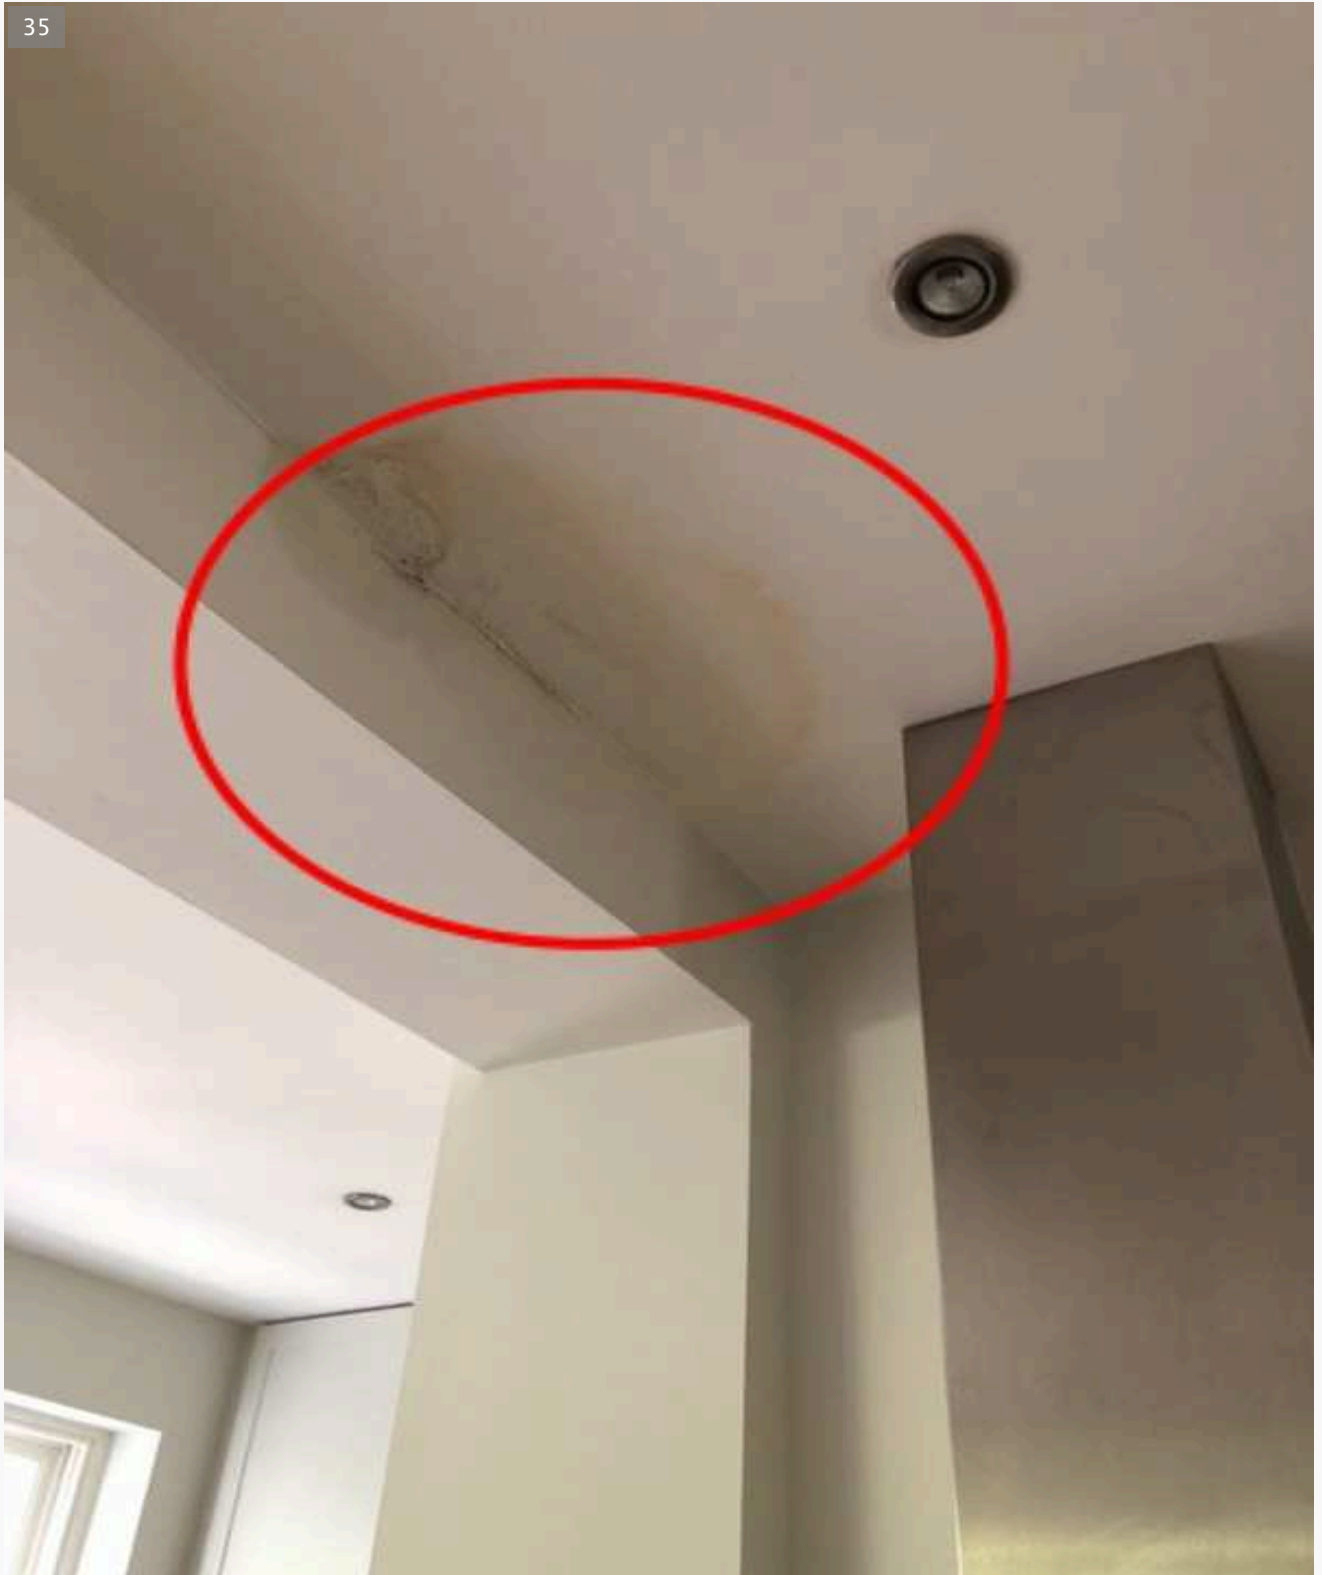
[Photo 35] Stain above cooktop.

We have used the slider to show the ceiling is damaged. We have flagged the item and used photo markup to bring additional attention to the damage.

Stain above cooktop.

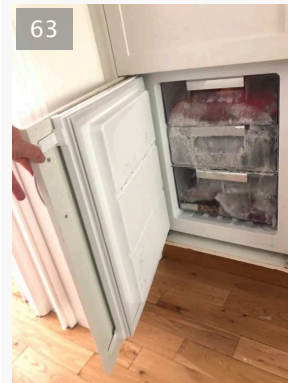
Freezer needs defrosting.
24/02/2021 12:47 (GMT)
at 51.57141126603429°, -0.1298182607733276°

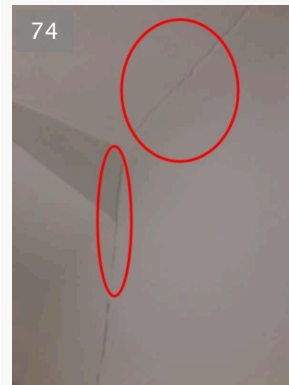
[Photo 74] Crack separation on the wall to ceiling on 3 sides of the perimeter.

Photo markup, photo caption, and flag used to bring attention to ceiling damage.

Crack separation on the wall to ceiling on 3 sides of the perimeter.

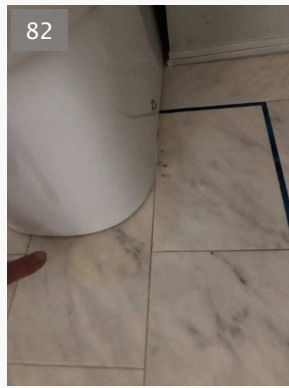
[Photo 82] Leaking water closest. Note this aligns approximately with ceiling below.

Leaking water closest.
Note this aligns approximately with ceiling below.
24/02/2021 14:07 (GMT)
at 51.57144640530343°, -0.1298319029032252°

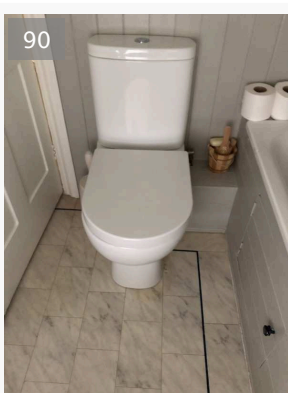
[Photo 90] Toilet is leaking. Note stains on floors.

Toilet is leaking. Note stains on floors.

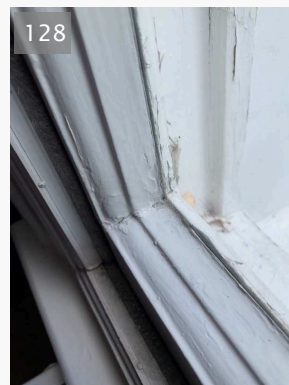
128

Some visible weathering,
deterioration of paint on
the exterior of the wood-
framed window.

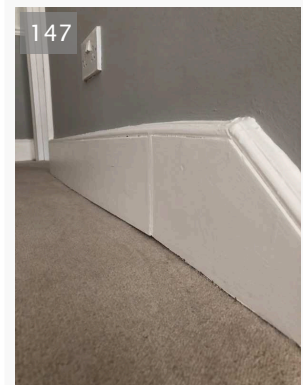
147

[Photo 147] Poorly fitted baseboard from landing to 3rd floor.

**Poorly fitted baseboard
from landing to 3rd floor.**
24/02/2021 14:20 (GMT)
at 51.57158432471942°,
-0.1296938362342097°

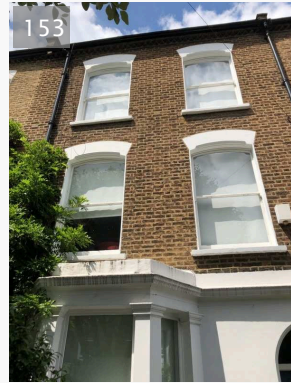
2nd and 3rd floor windows are wood sash windows. Paint generally good condition, showing some weathering on the horizontal elements.

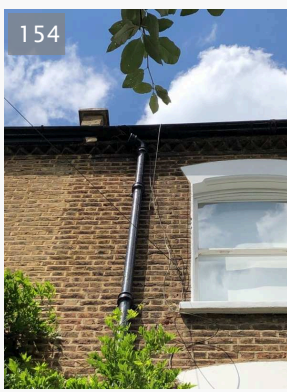
[Photo 154] Downspout on left side of property not connected. There is discontinuity at party wall.

Downspout on left side of property not connected. There is discontinuity at party wall.

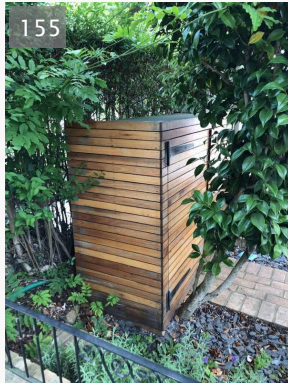
[Photo 155] Shed at entry generally in good condition, showing some weathering.

155
Shed at entry generally in good condition, showing some weathering.
24/02/2021 12:22 (GMT)
at 51.5714379153023°, -0.1297978142380606°

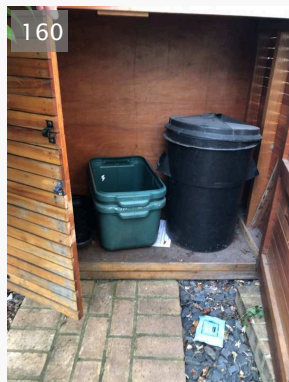
[Photo 160] Wood enclosed rubbish closet located front left yard, somewhat weathered condition.

160
Wood enclosed rubbish closet located front left yard, somewhat weathered condition.
24/02/2021 12:18 (GMT)
at 51.57136782223917°, -0.1297165035980137°

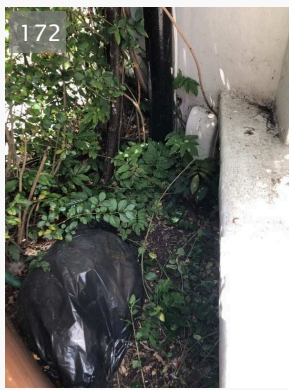
Down pipe terminates at grade on the left side of the property. Note this is a down pipe that is not connected. Down pipe to the right of the property in the adjacent unit is connected and terminates at a concrete surface and catch basin. See separate photo.

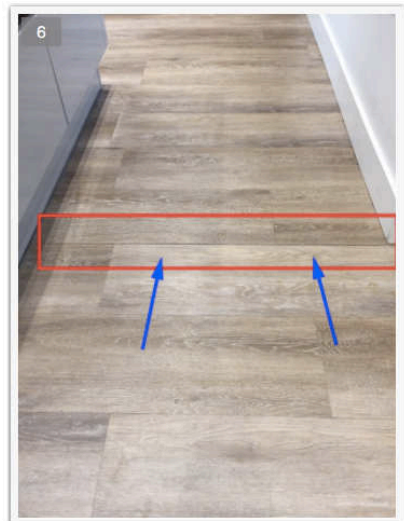
View of kitchen floor, existing joint over solid concrete extension floor. Uneven joint observed, gap in covering.
01/02/2021 15:58 (GMT) at 52.13126961612341°, -0.012146634981047498°
