## RICS Level 3 Building Survey

100 Holland Road  
Sutton Coldfield  
B72 1RE

Client Name:	Abdulrahman Abodarahim
Client Reference:	23-2028
Appointed Surveyor:	Muadh Rehman
Date of Survey:	7th September 2023

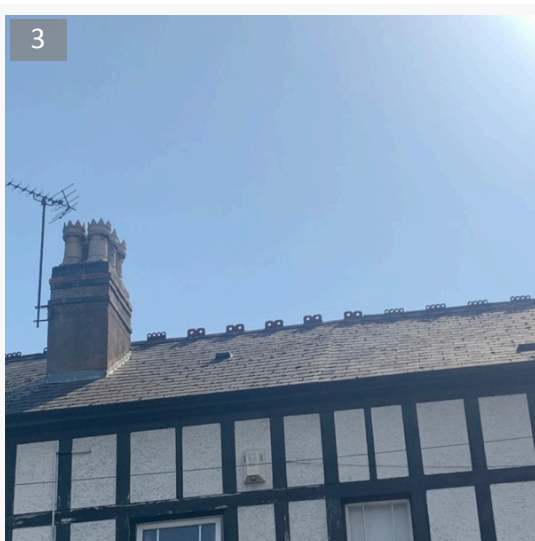
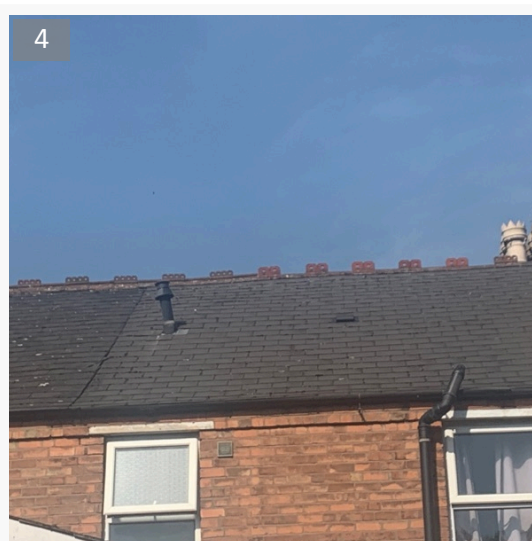
There is some moss growth noted to the main roof.

As viewed externally from ground level using high-powered binoculars the main roof slopes appeared to be free of signs of serious deflection or undulations. The roof covering generally appears in satisfactory and serviceable condition considering its age and type and should benefit from an extended life subject to implementing typical maintenance.

Moss or lichen growth typically occurs in instances whereby the roof tile covering surfaces wear and retain moisture, which is essential for the aforementioned plant growth to take hold as a key. The fibrous roots of the plant can continue extending to nearby areas, eventually causing further damage to the nearby surfaces.

We would ideally recommend a full roofing inspection by a competent roofer prior to purchase to ascertain the full extent of the repairs required to the roof and an estimation on its life span.

We recommend low pressure washing and sweeping of the roof covering to dislodge organic deposits and prevent standing forms of precipitation from being held onto the tile surface. This can potentially cause degradation of the tile face coats, or alternatively be potentially blown in underneath the tiles in driving horizontal winds, introducing timber rot and degradation issues to the constituent timber elements within the main roof space.

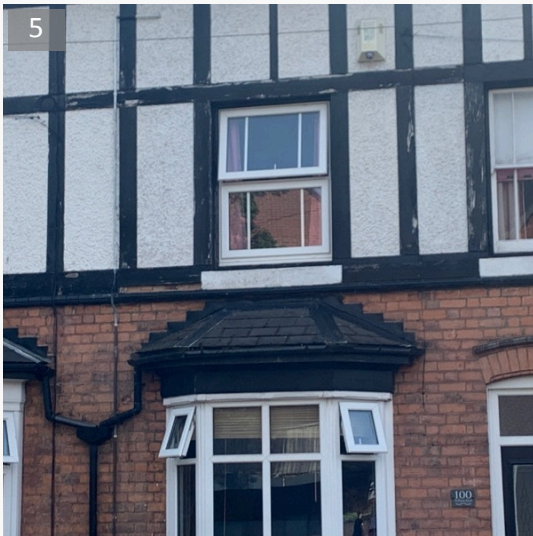
At the rear to the kitchen extension and bay is a single pitch surmounted in slate tiles, with an angled ridge embedded in mortar. Elements of this was broken away that is to be repointed. Moss can be cleared off. Against the external wall is adequate flashing applied.

We have not noted deflection/bowing to the secondary roof.

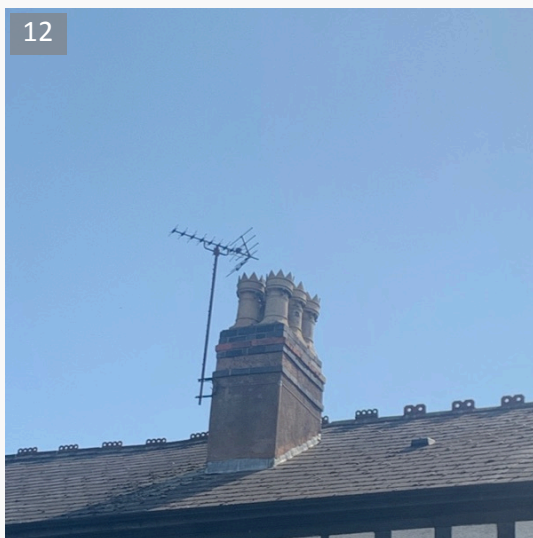
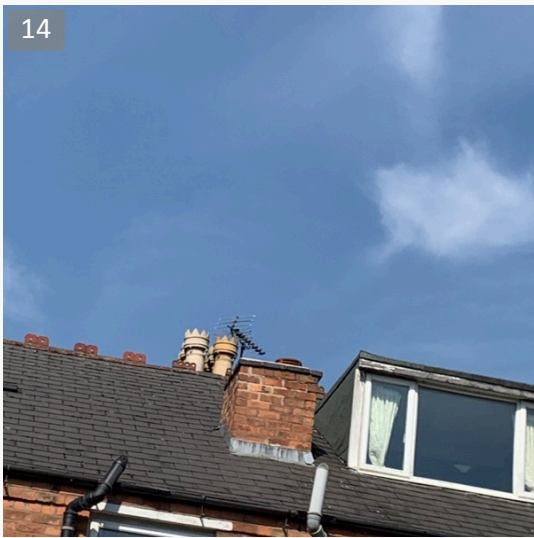
Corbelling brickwork has been installed to the stack; this is brickwork that staggers outwards at the top of the main chimney stack often found just before the flaunching, that secures the chimney pots. Its function can be to either add decorative interest, allow the chimney pot bases more room to be fitted internally and/ or to throw rainwater away from the base of the chimney.

The chimney stacks above the roof level appear generally stable and not excessively slender or excessively vulnerable to wind loads (i.e. the height of the stack is less than 4.5 times its width). The mortar pointing, flaunching and flue pots all look satisfactory considering the property age and type and do not require any urgent repairs in the short term.

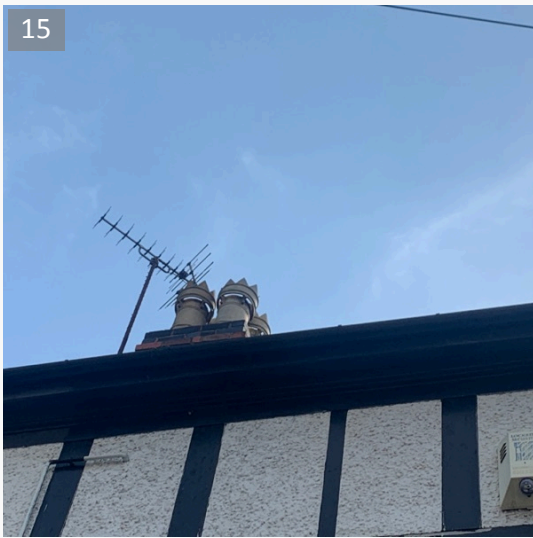
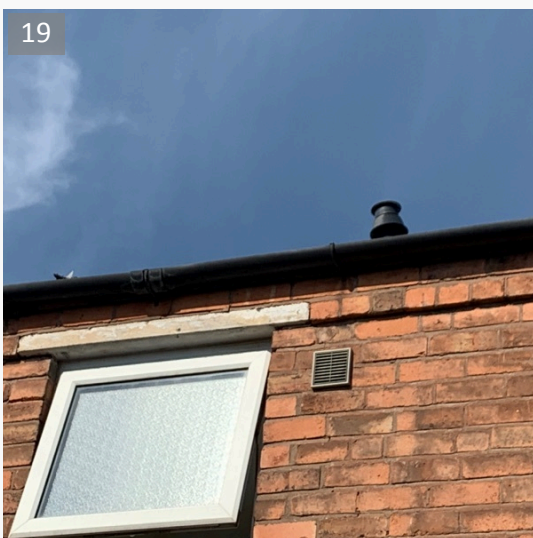
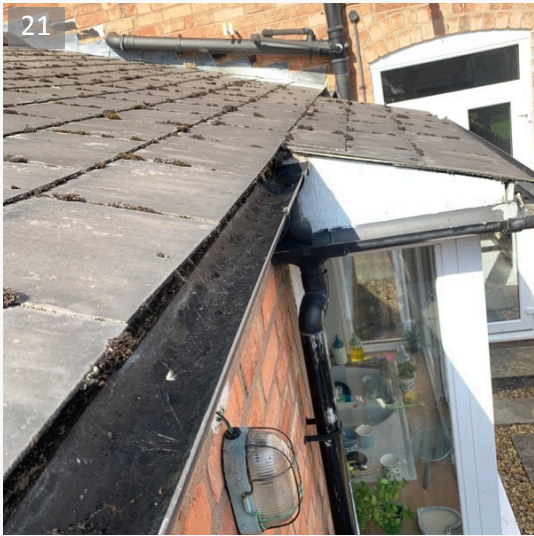
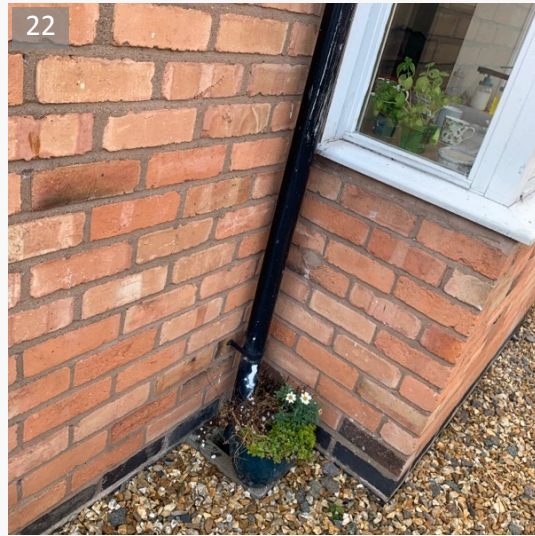
The gutter to the bay is found with algae and moss between the joints. These are to be cleared out and assessed during rainfall. The downpipe discharges onto the ground.

Rainwater pipes discharging onto the ground/hardstanding(s) encourages pooling and splashing of water and detritus local to the base of adjacent walls and could cause damp and localised flooding in high volumes of rainfall. It would be recommended that such pipes are extended into the nearby drains/surface water gullies.

A cover is recommended that can be removed for cleaning when required. The gutters and downpipes should be checked regularly during rainfall and any leakages repaired as a matter of urgency. The rainwater goods should be cleared through regularly to prevent any overflow and blockages caused by leaves and debris.

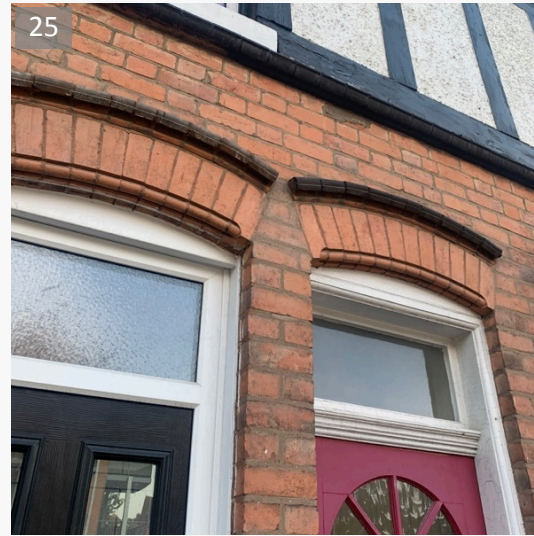
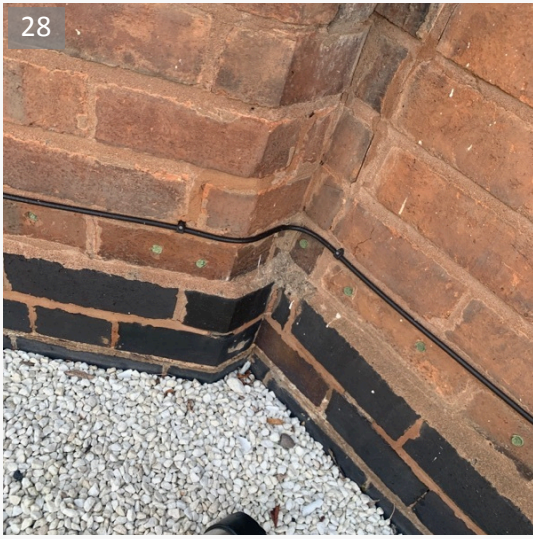
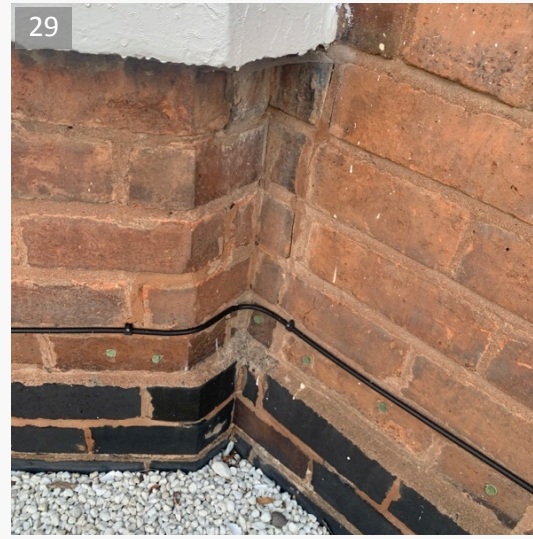
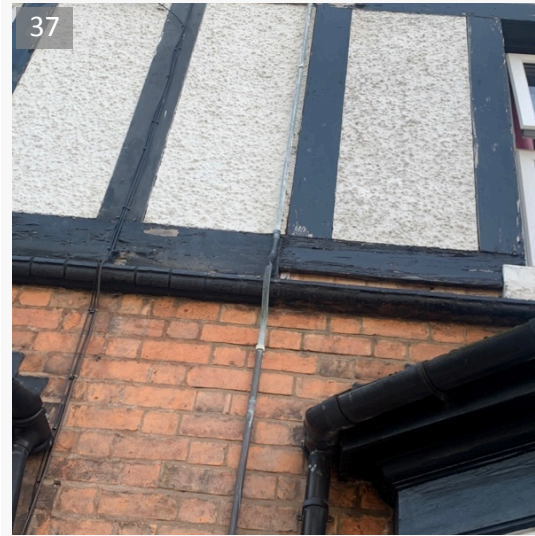
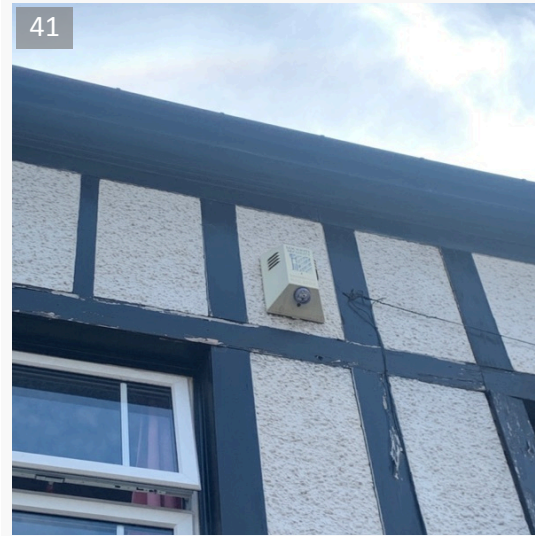
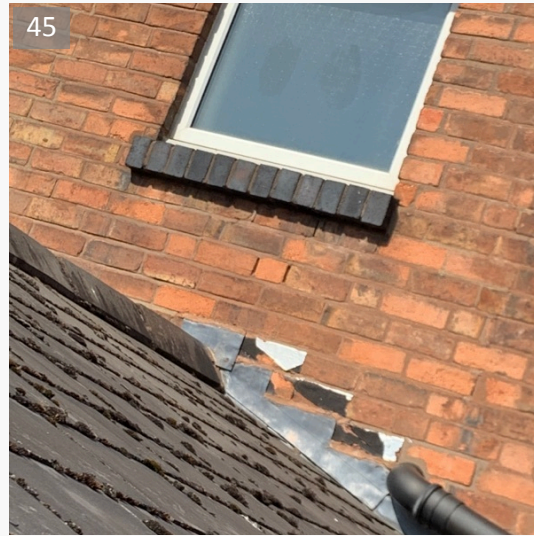
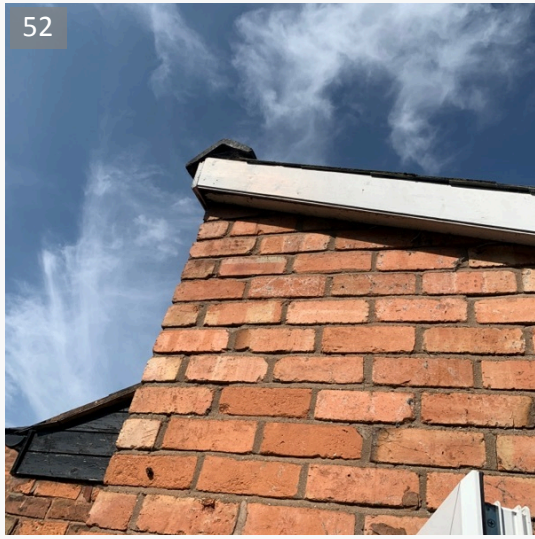
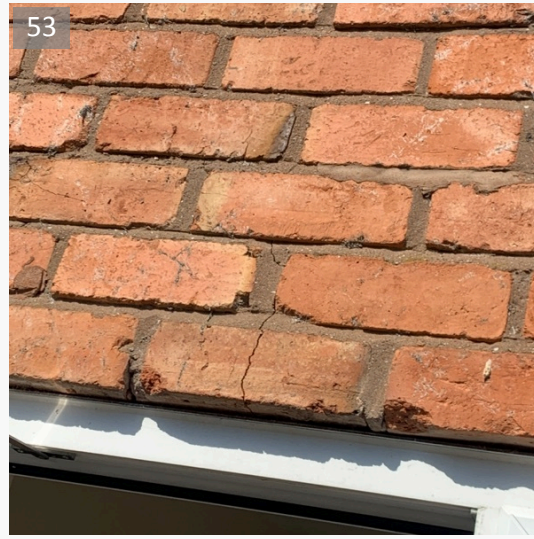
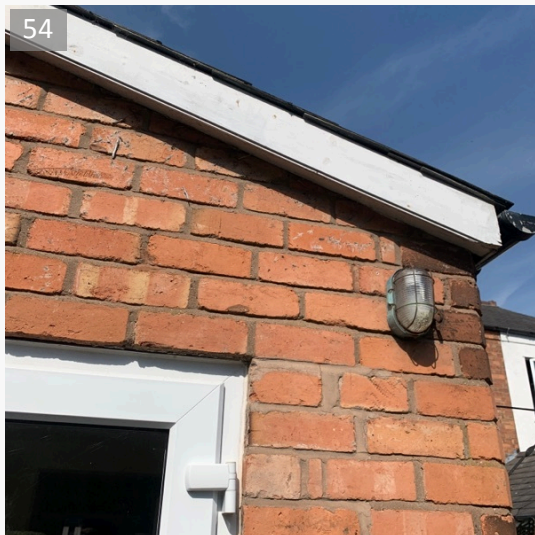
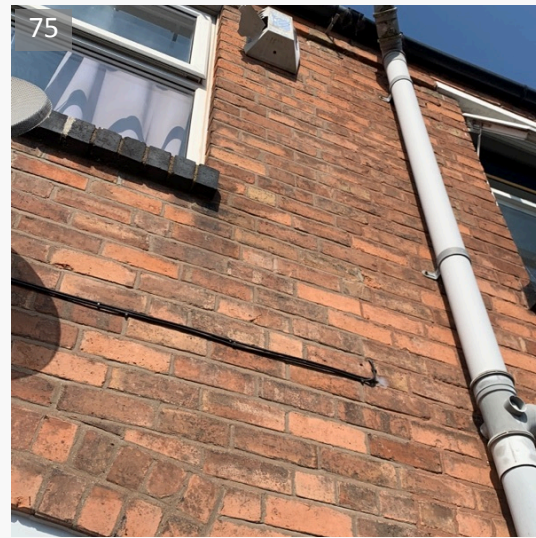
The timber panels have rotted and dated where they are prone to carry moisture through its cracks. Ideally we would recommend that these are to be completely upgraded and replaced with modern forms of PVC that cannot rot and easier to maintain. You should confirm if there are any legal obligations that will prevent the actions of these through your legal advisors.

Spalled bricks are noted sporadically these are to be repaired by mason by cutting out and replacing.

To the rear elevation at the kitchen wall, from the edge of the bay window there is a horizontal crack between the mortar. This is to be patched up by a masonry where possible building movement has occurred to where the soil vent pipe drains. A structural engineer is to examine the extent of the crack and monitor movement over time. Beside the rear kitchen window elements of the masonry has already been repointed where historic crack may have formed. And above the kitchen patio doors the crack to the brick can be replaced by a mason.

Moss and algae stains, in addition to vines are to be cleared off the brickwork.

We recommend that the render be maintained in a watertight condition, i.e., infilling any cracks with similar render to match to prevent precipitation ingress beyond the render which could otherwise become trapped and cause penetrating damp issues as well as early degradation of the underlying brickwork and peeling of the render coat. You could use external sealant as a temporary fine crack filler to keep the render watertight until proper repairs are undertaken.

Where mortar has broken away we would recommend that these are repointed to ensure watertightness.

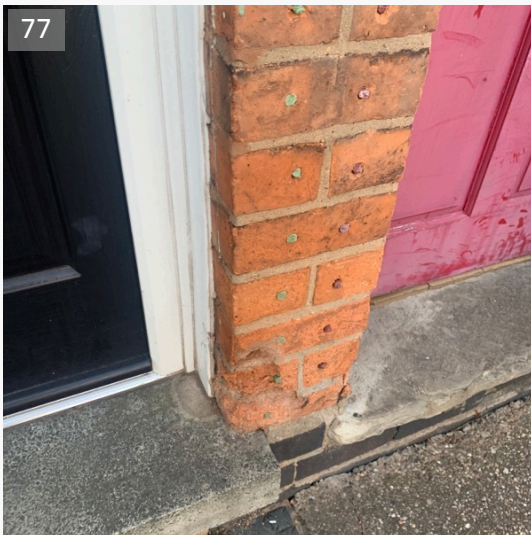
We noted a series of previously plugged drill holes at low level to the external walls. This could be indicative of historic, recent or preventative damp that has received chemical injection. Installing a chemical damp-proof course involves in modern times, usually involves injecting a silicone-based formulation into a series of holes formed along the base of a wall that is suffering from the effects of dampness.

We would recommend any warranties or guarantees are requested.

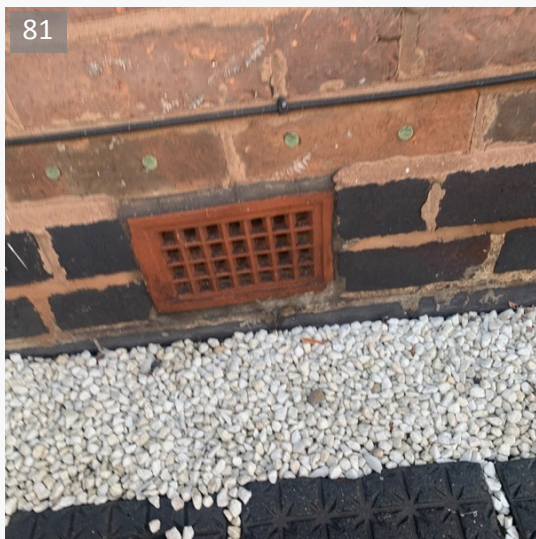
Air bricks are visible to the property.

The level of the airbricks at the base of the external walls is notably low in relation to the external hardstanding. This could potentially attract water into the ground floor zone and produce environments conducive to rot and dampness to the ground floor timbers. Ideally, introducing periscopic ducts is recommended, to raise the level of the airbrick up away from the external patio (i.e. provide a vertical clearance of 75mm minimum), or reduce the finished ground level. This is in order to avoid the airbrick acting as an open gully, attracting damp and moisture into the floor zone and the surrounding wall structure, whilst still maintaining ventilation to the ground floor timbers.

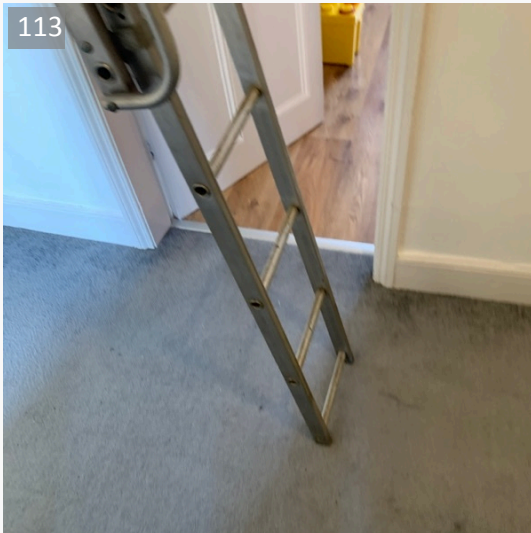
It would be recommended to further monitor the situation and if necessary, contact a roofing specialist regarding further ventilation to the void (crossflow is needed by fitting eaves, roof and soffit vents). Care needs to be taken as certain factors can result in the situation becoming worse.

White mould on roof timbers can be treated with a proprietary boric acid antifungal spray, which is usually non-toxic to occupants.
