**CARBON SIX
LETTINGS**

Sample Check In Report

123 Sample Road
City
Postcode

Company	C6 Lettings
Date of Inspection	24/02/2021
Prepared by	C6 Lettings
Inspected By	Mr. Inspector
Agent	Ms. Agent
Adults	2

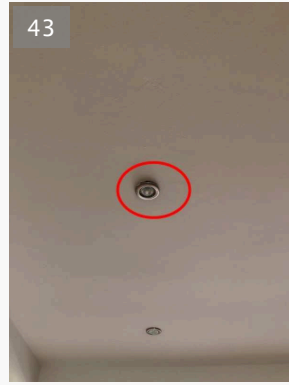
1 light fixture pulling out
of the ceiling. All others
are functional.

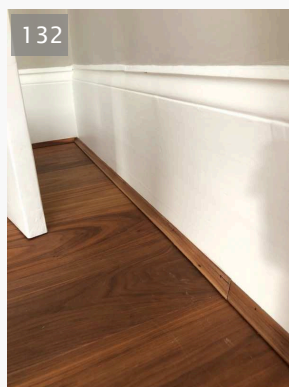
Baseboard generally in good condition.
24/02/2021 14:15 (GMT)
at 51.57139650086744°, -0.1297354636375956°

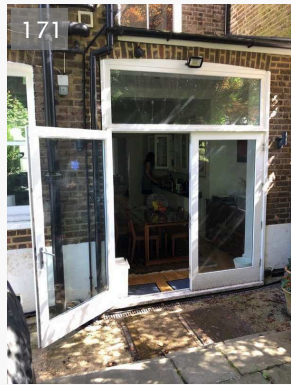
Rear wooden french doors, appears serviceable, useable condition.
24/02/2021 15:10 (GMT)
at 51.57143990998938°, -0.1298172316053907°

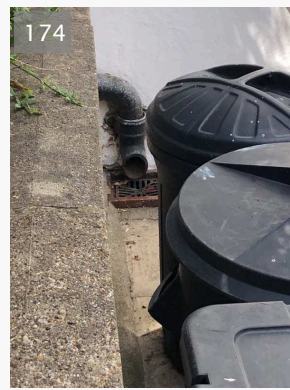
Downpipe termination at adjacent property to the right of subject property showing termination at catch basin.
24/02/2021 12:26 (GMT)
at 51.5715256366576°, -0.1298390105448993°
