## RICS Level 3 Building Survey

100 Holland Road  
Sutton Coldfield  
B72 1RE

Client Name:	Abdulrahman Abodarahim
Client Reference:	23-2028
Appointed Surveyor:	Muadh Rehman
Date of Survey:	7th September 2023

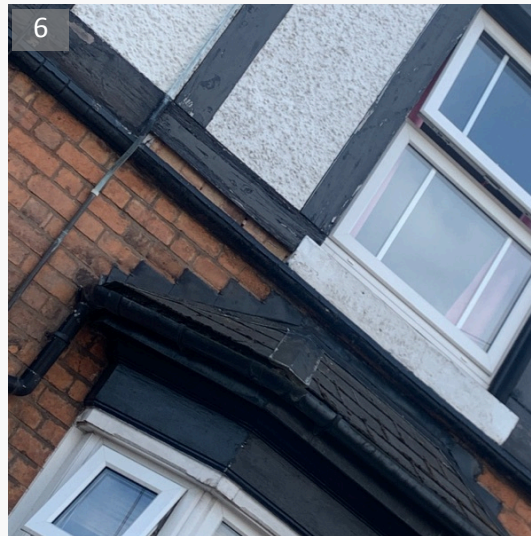
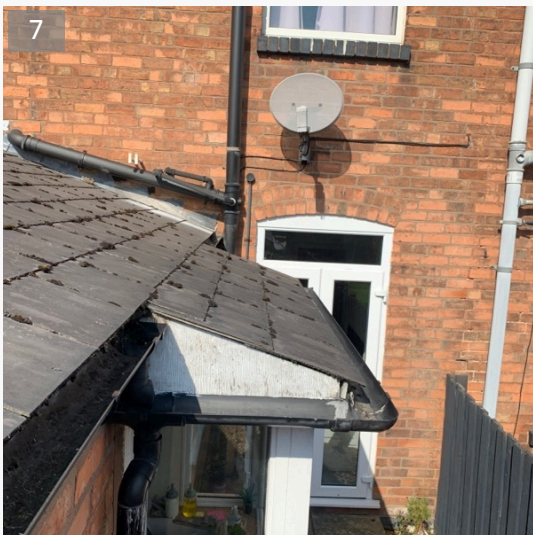
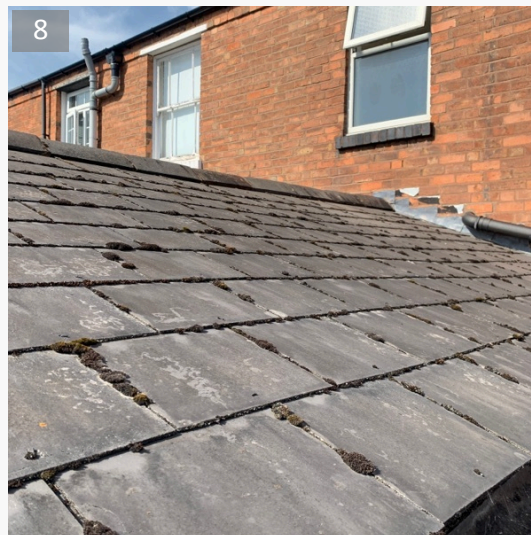
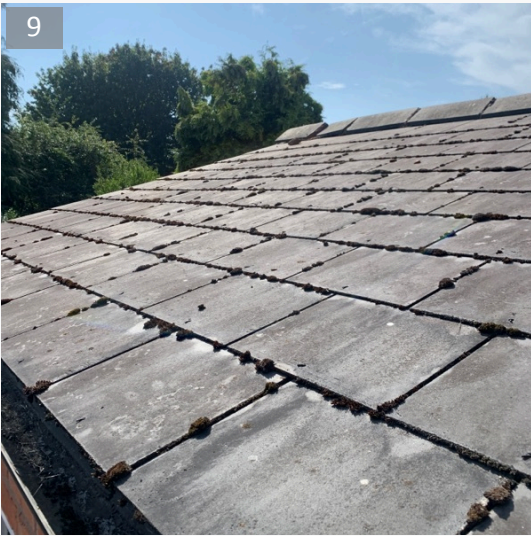
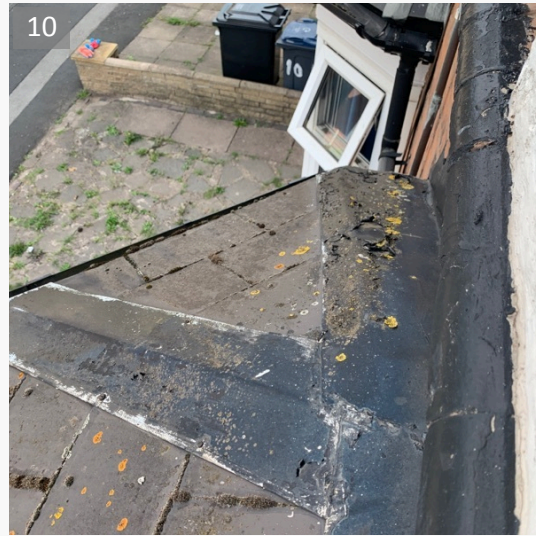
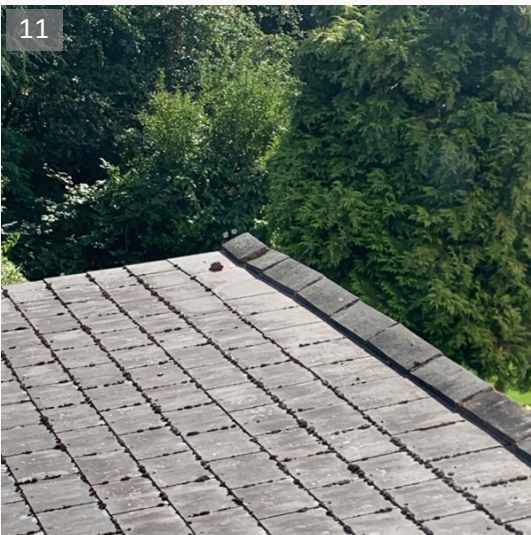
At the rear to the kitchen extension and bay is a single pitch surmounted in slate tiles, with an angled ridge embedded in mortar. Elements of this was broken away that is to be repointed. Moss can be cleared off. Against the external wall is adequate flashing applied.

We have not noted deflection/bowing to the secondary roof.

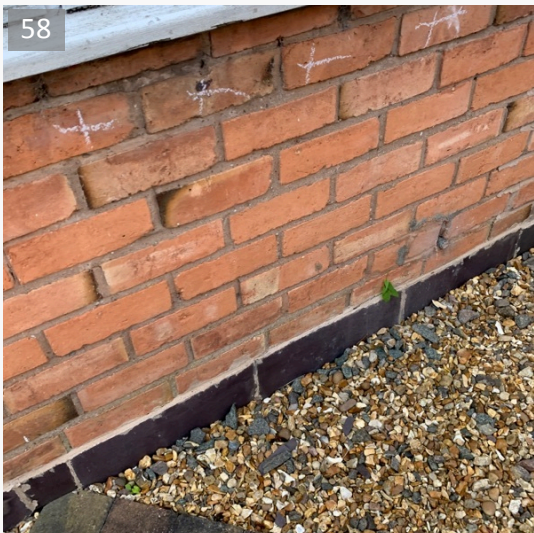
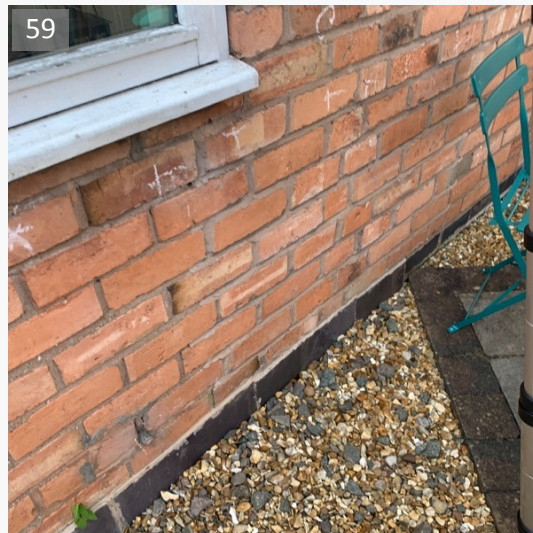
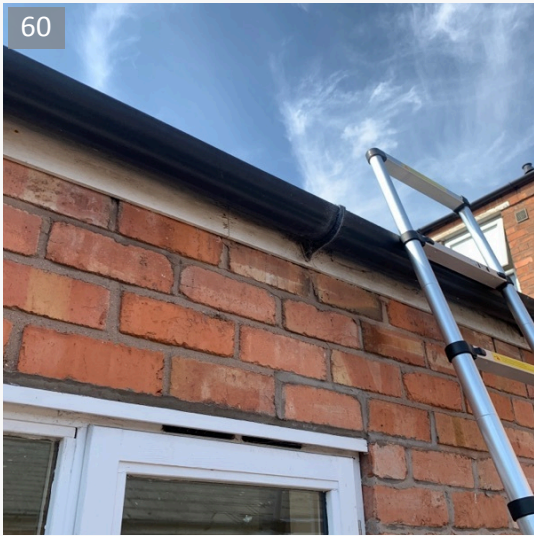
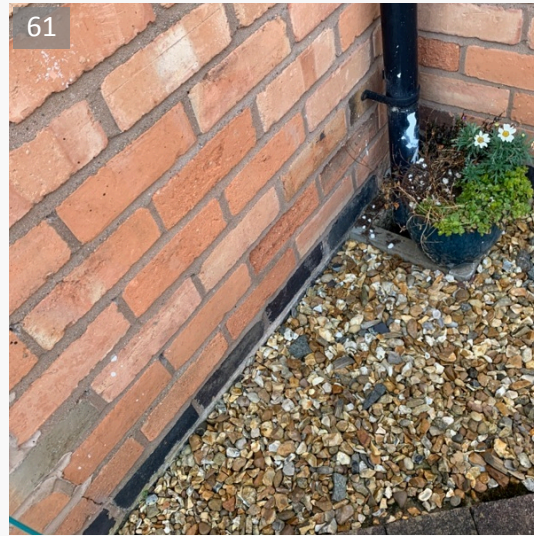
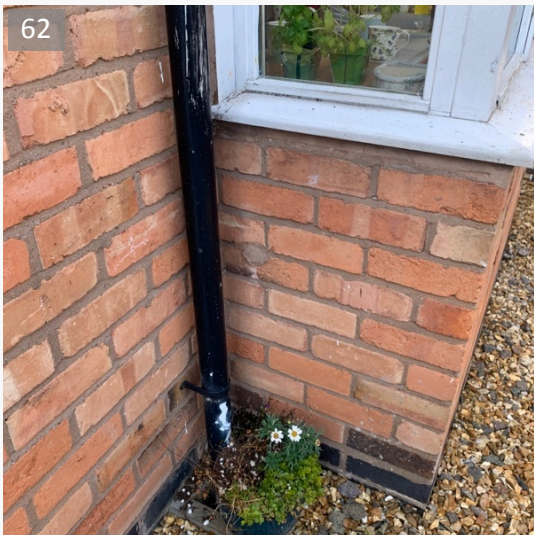
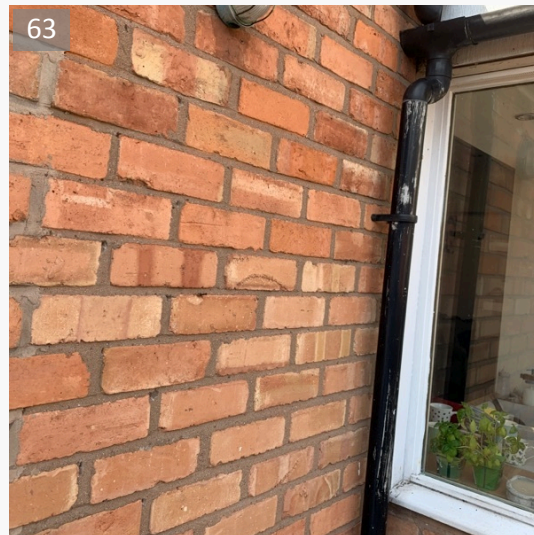
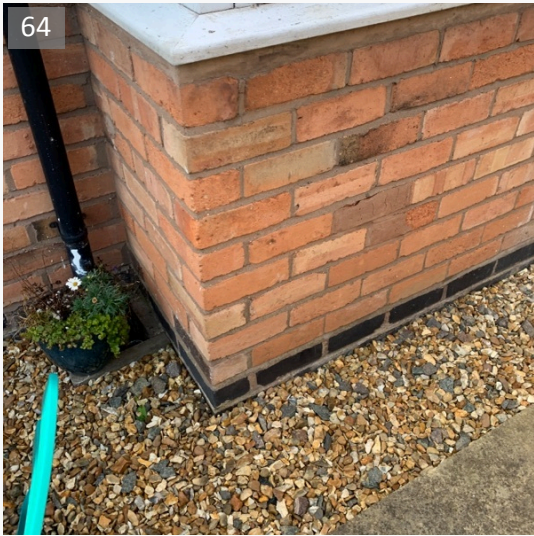
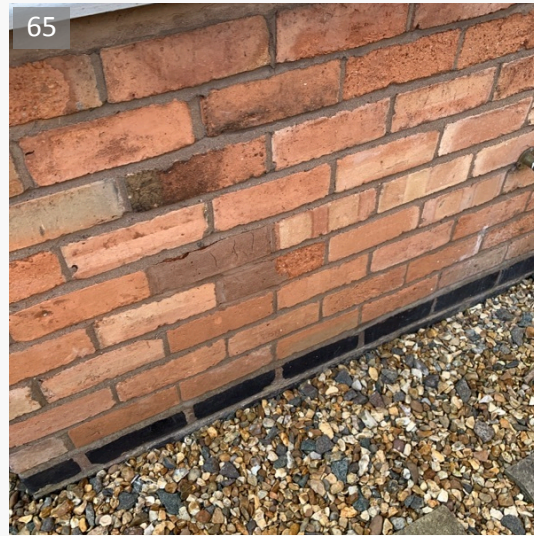
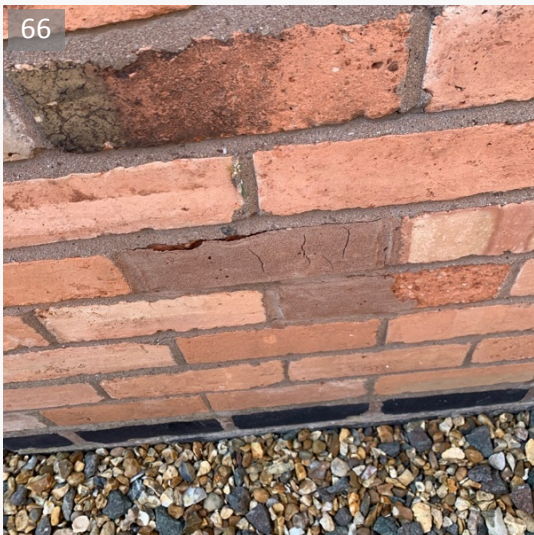
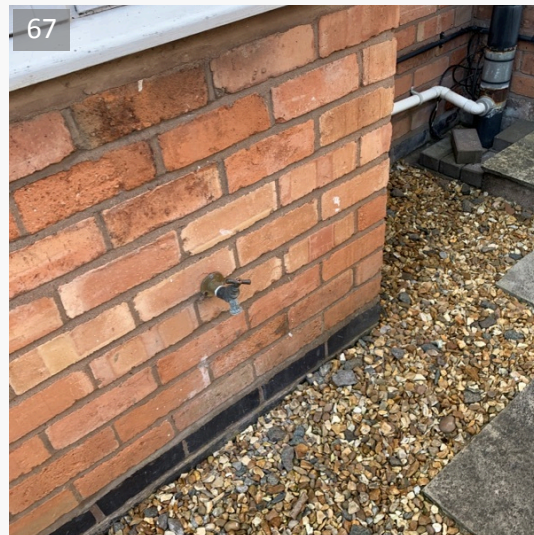
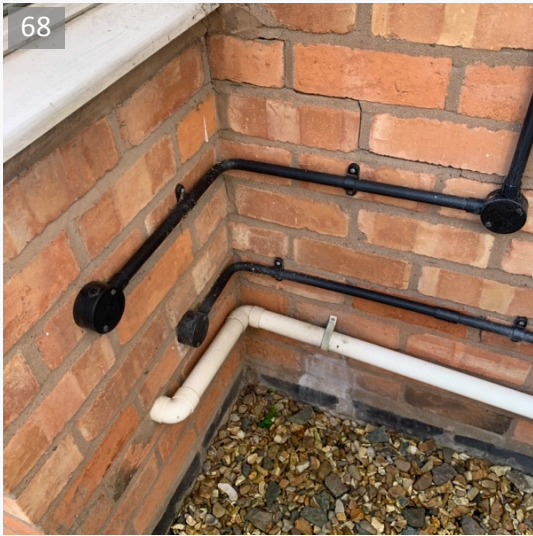
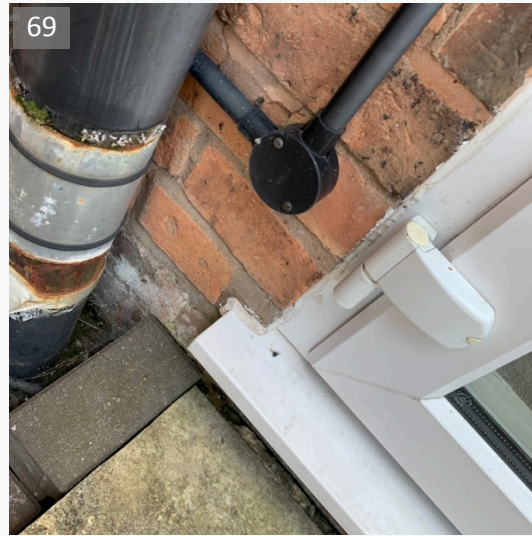
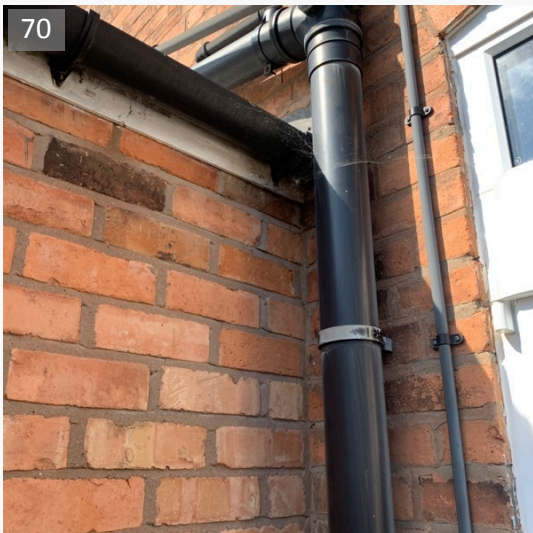
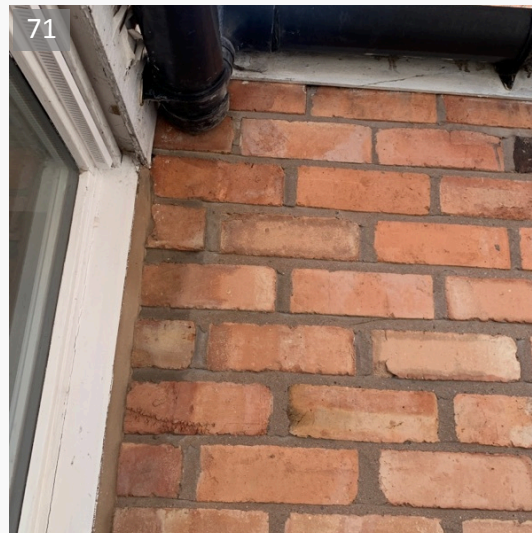
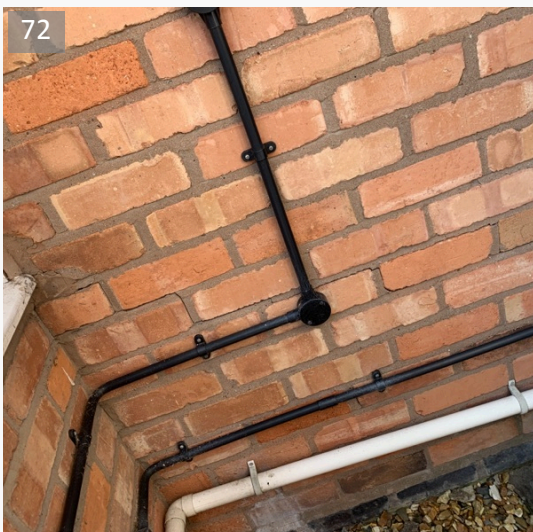
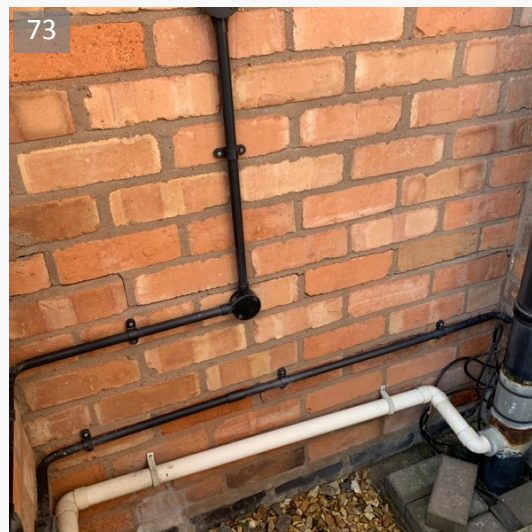
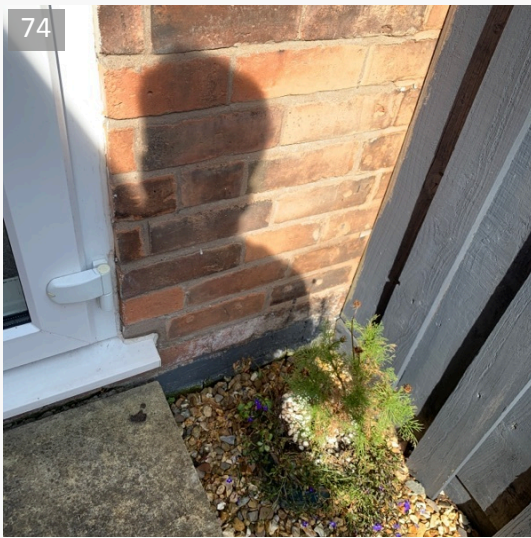
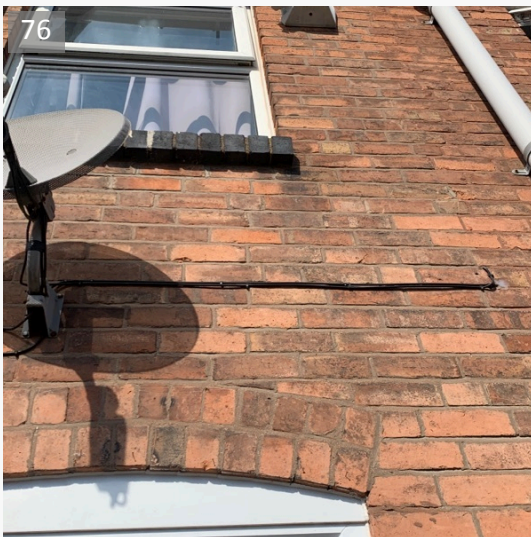
Condition Rating 3

We noted a series of previously plugged drill holes at low level to the external walls. This could be indicative of historic, recent or preventative damp that has received chemical injection. Installing a chemical damp-proof course involves in modern times, usually involves injecting a silicone-based formulation into a series of holes formed along the base of a wall that is suffering from the effects of dampness.

External Wall Repointed	£ 3000.00	Plus VAT
Spalled Bricks Cut Out And Replaced	£ 1000.00	Plus VAT
Cables And Pipes Set In Watertight Condition	£ 100.00	Plus VAT
General Render Repair And Filling	£ 1000.00	Plus VAT
Timber Mock Tudor Joinery To Be Replaced By PVC	£ 3000.00	Plus VAT
Crack To Be Patched Up By Mason	£ 600.00	Plus VAT
Vines To Be Cleared Off	£ 60.00	Plus VAT

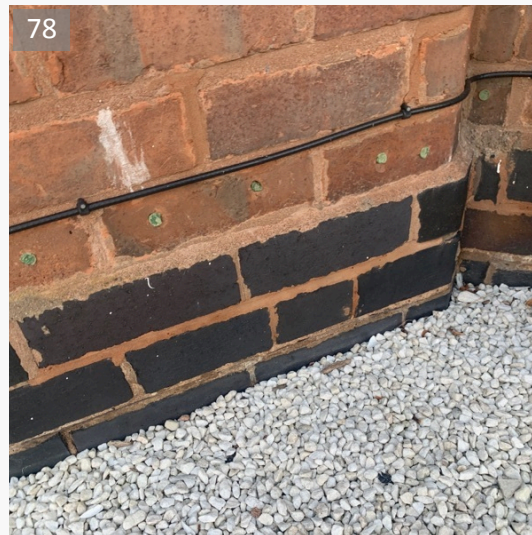
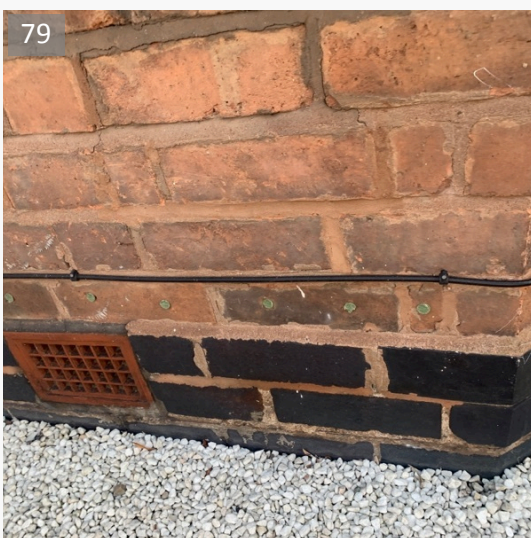
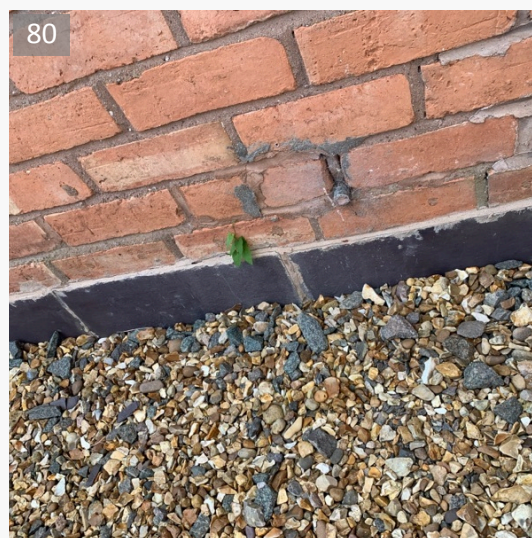
**Condition Rating 2**

The level of the airbricks at the base of the external walls is notably low in relation to the external hardstanding. This could potentially attract water into the ground floor zone and produce environments conducive to rot and dampness to the ground floor timbers. Ideally, introducing periscopic ducts is recommended, to raise the level of the airbrick up away from the external patio (i.e. provide a vertical clearance of 75mm minimum), or reduce the finished ground level. This is in order to avoid the airbrick acting as an open gully, attracting damp and moisture into the floor zone and the surrounding wall structure, whilst still maintaining ventilation to the ground floor timbers.

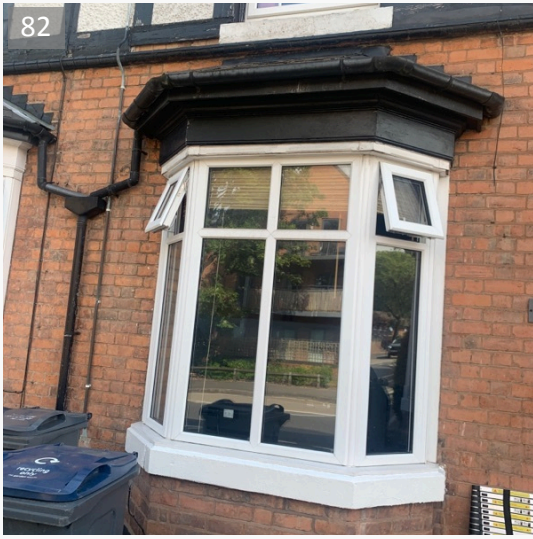
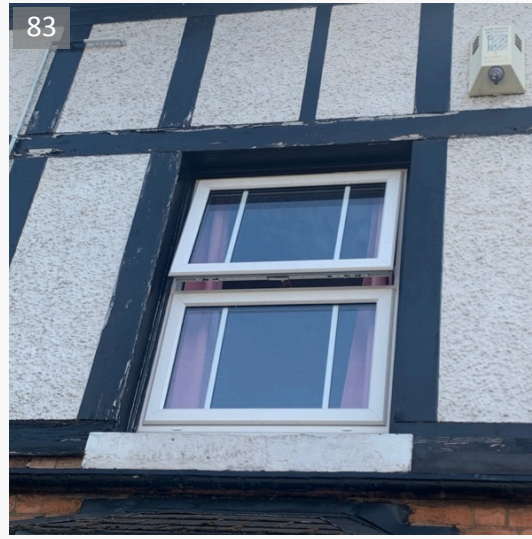
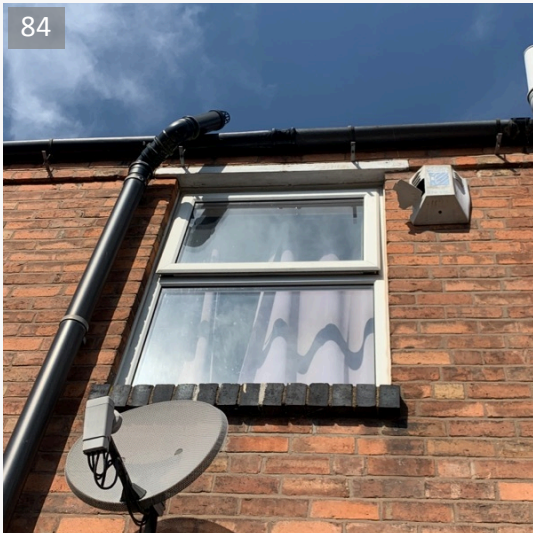
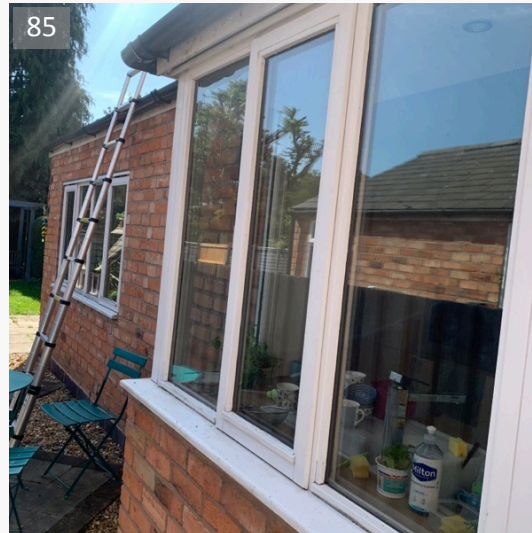
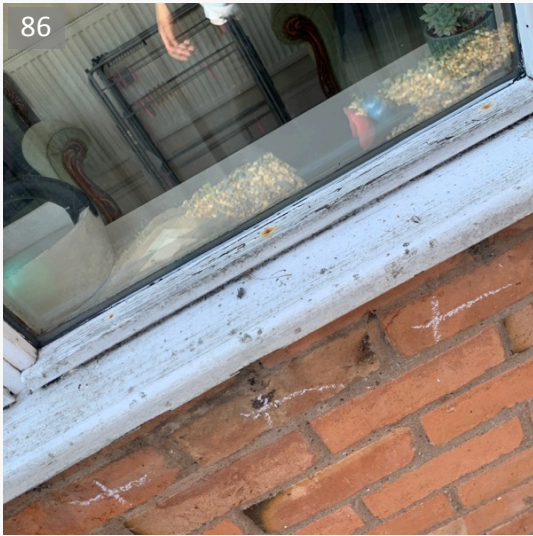
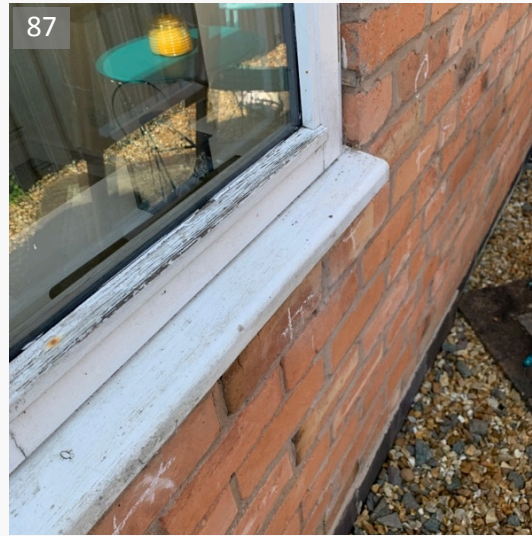
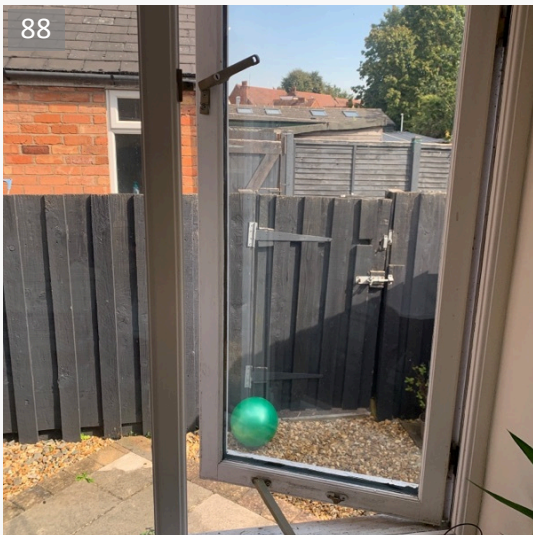
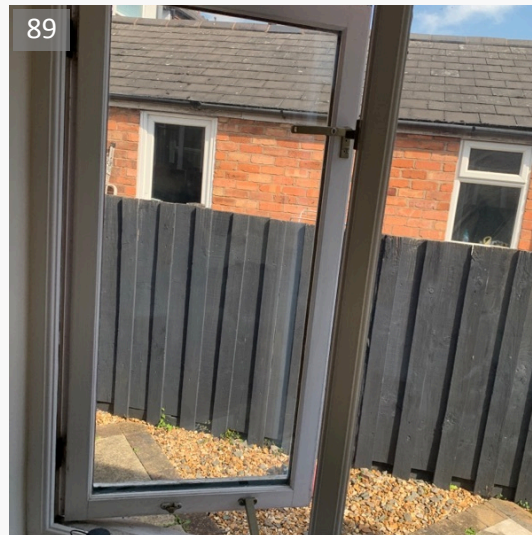
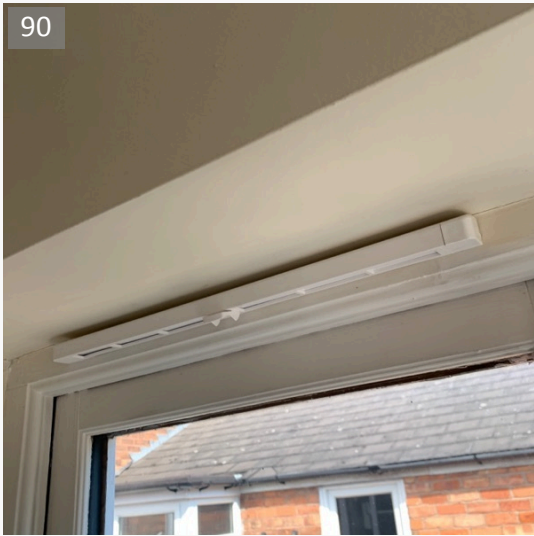
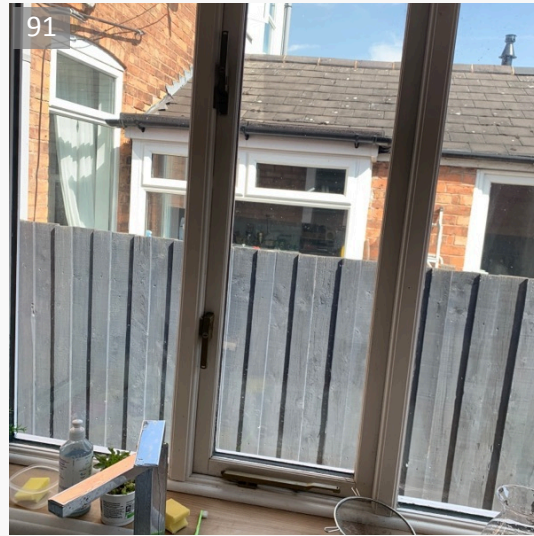
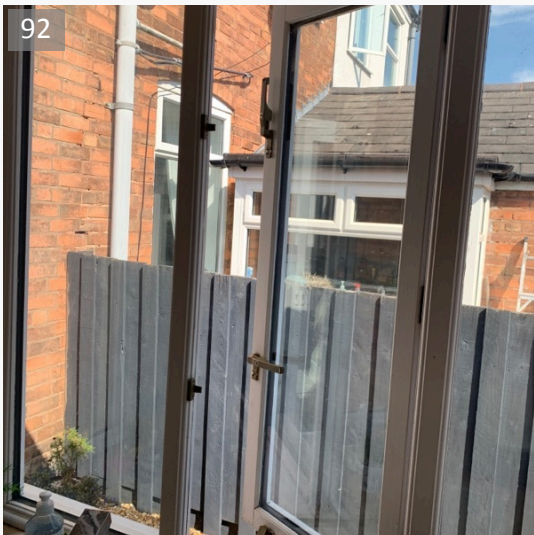
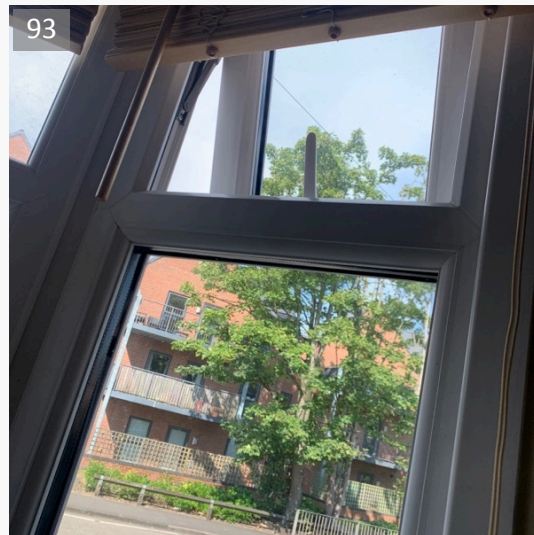
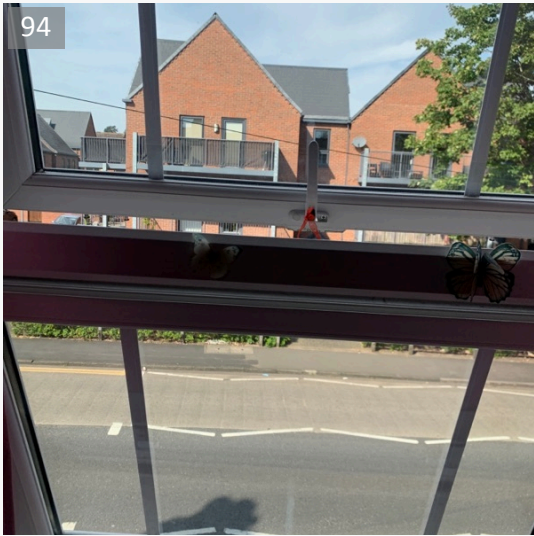
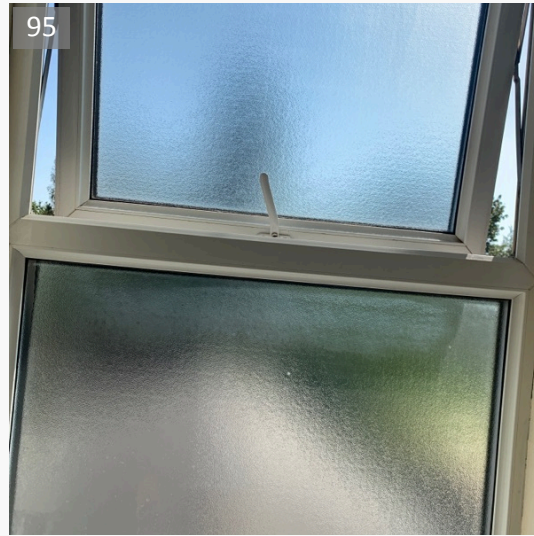
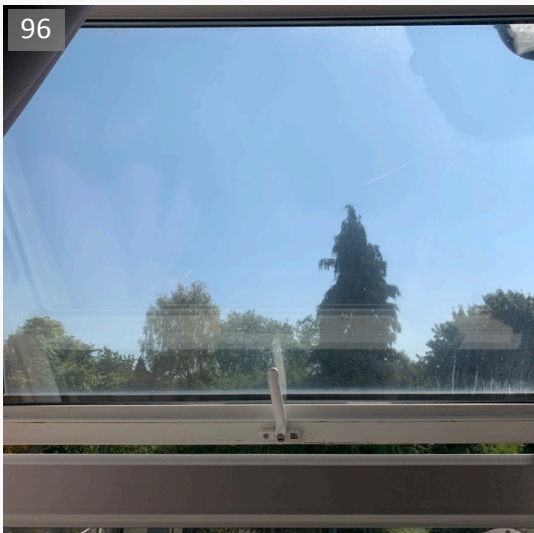
Condition Rating 2

At the kitchen to the bay and further window there are timber double glazed casements. These are in poor condition as the frames have rotted and are in need of upgrading. The window although were found to open and close well.

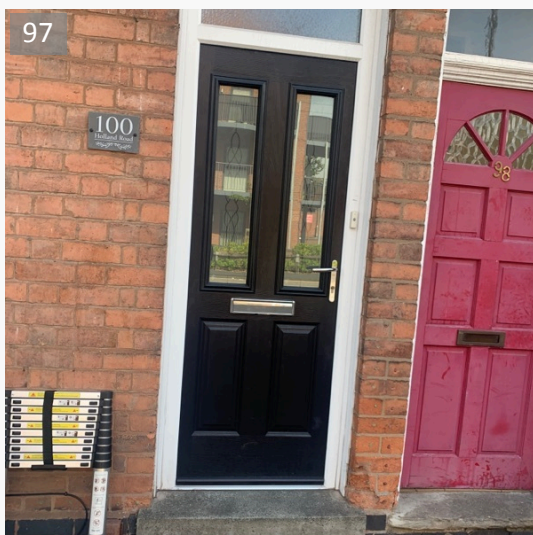
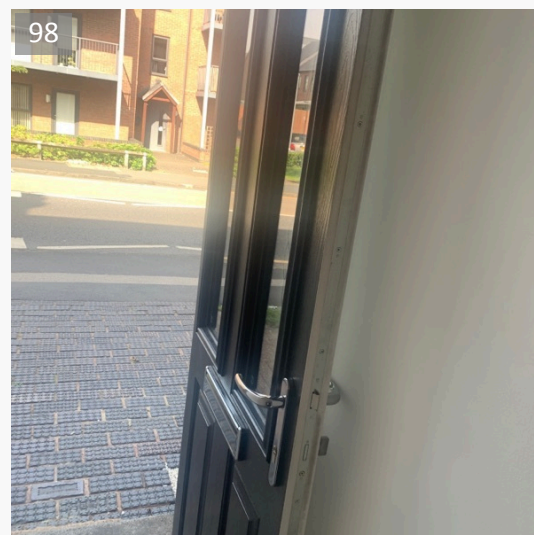
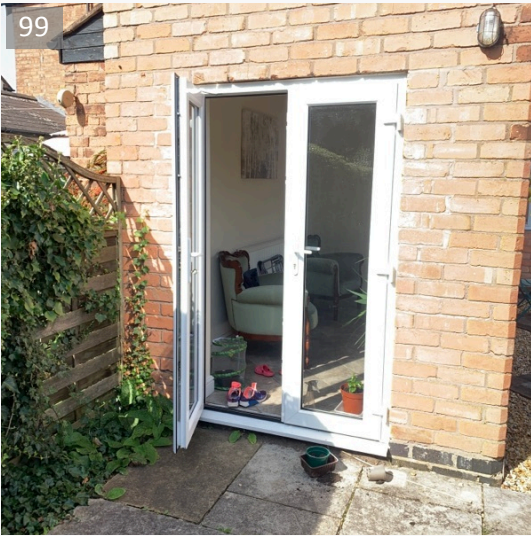
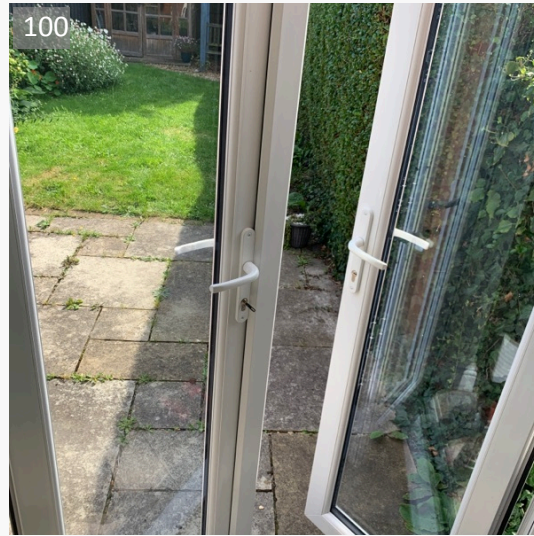
Condition Rating 2

The external doors are generally robust and serviceable without major defects.

You should ensure the junctions of the doorframes and masonry are sealed and kept in good order. If the seals become cracked or damaged, then water penetration can occur in bad weather.

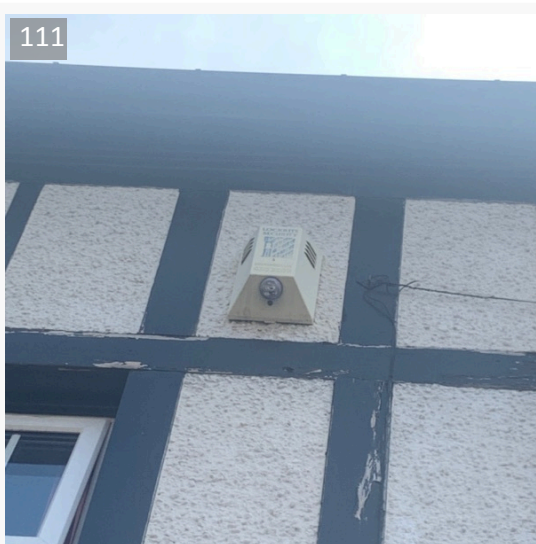
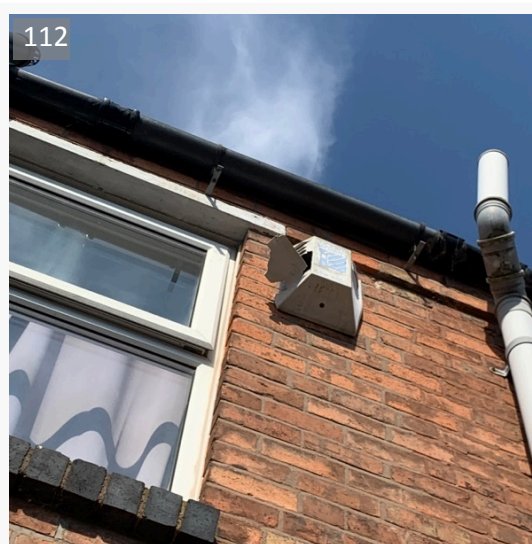
There are security badges set to the property with the rear case damaged, no internal alarms are fitted.

There are always ways to improve the security of your property. Burglars like to operate under cover of darkness and by installing external motion sensor floodlights, these act as a deterrent. Intruder alarms are a good way to improve security and reduce your insurance premium, these should be serviced annually.

Patio doors can be protected by fitting purpose-made locks or a security bar. Window locks that pull the window into the frame with a key are stronger than normal locks.

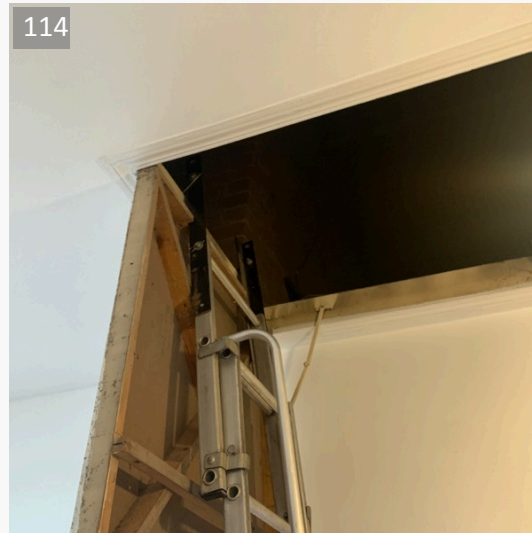
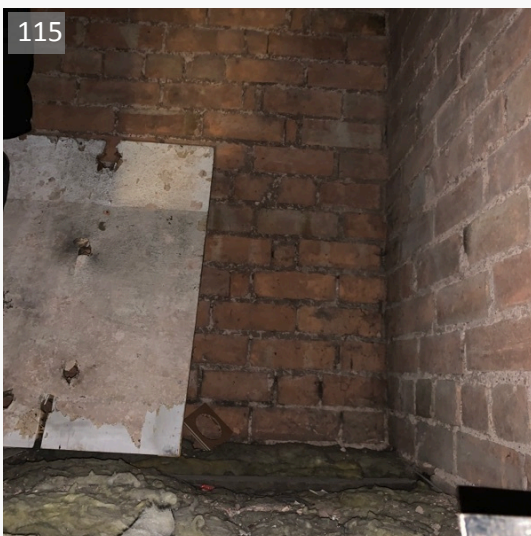
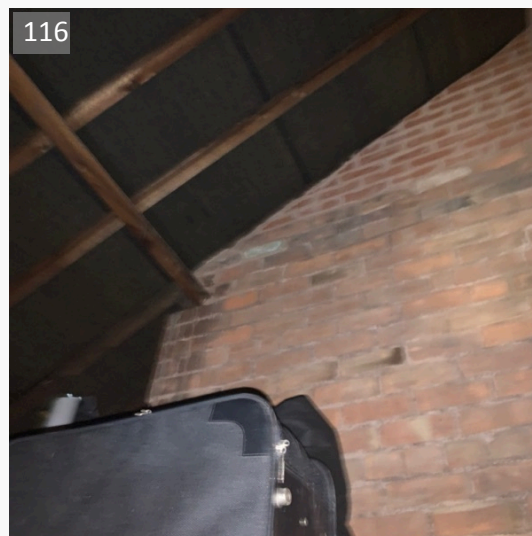
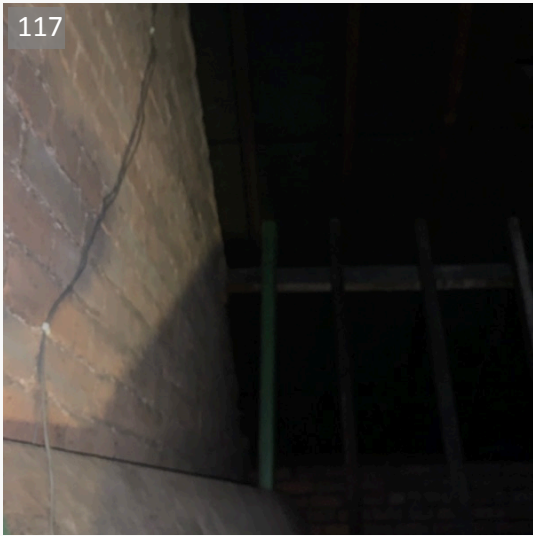
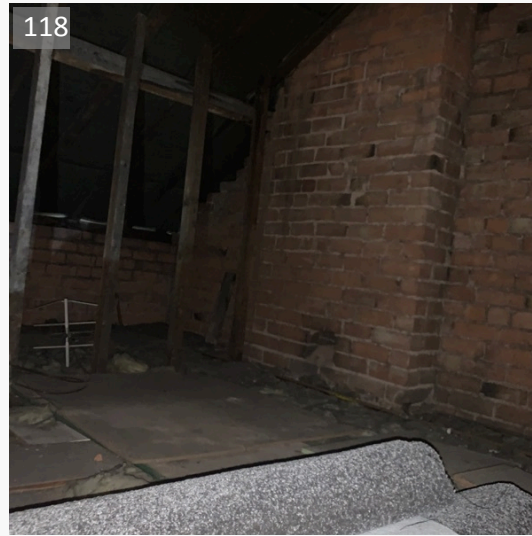
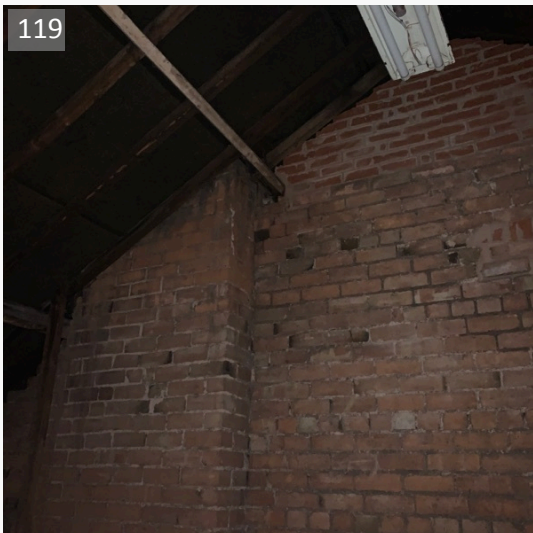
Where inspected the roof structure was found to be generally sound with only slight deflection on the underside of the original timber rafters which we feel is within tolerable limits. The roof slopes are generally even. Where they are undulating, this is on a small scale and there is no evidence to suggest the distortion will get worse.

The purlin ends are built close to or into the party wall and may suffer from the presence of moisture and condensation effects from the air in the roof void and from the brickwork to the party wall. It is recommended that the timbers are preservative treated.

The loft floor insulation thickness appears to fall below modern standards and you may wish to upgrade this to 300mm thickness of quilt type insulation, although I refer you to the EP Certificate for the performance of the building overall. Insulation quilting should not cover downlighters (or other electrical installations) to avoid wiring overheating risks. We have identified some white surface mould growth within the roof void. Roof structures of this nature are intended for little or no insulation or underfelt. This is more than likely caused by condensation. White mould tends to grow in high humidity environments rather than areas suffering from total saturation.

It would be recommended to further monitor the situation and if necessary, contact a roofing specialist regarding further ventilation to the void (crossflow is needed by fitting eaves, roof and soffit vents). Care needs to be taken as certain factors can result in the situation becoming worse.

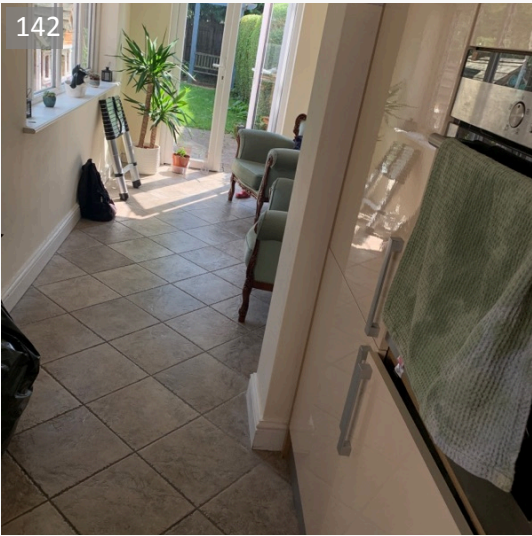
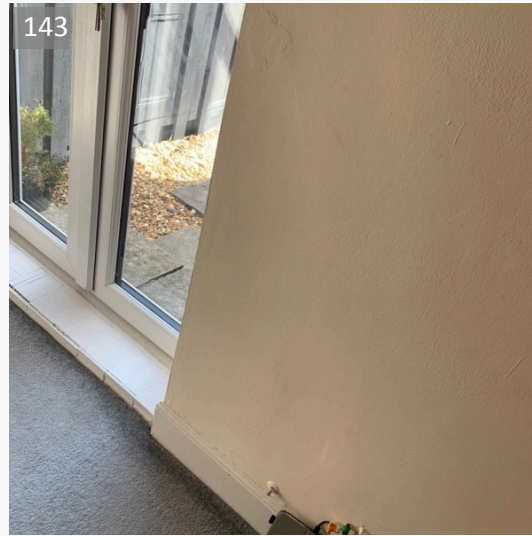
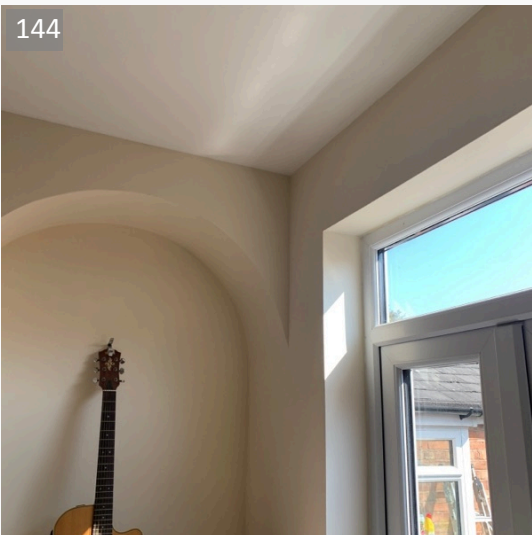
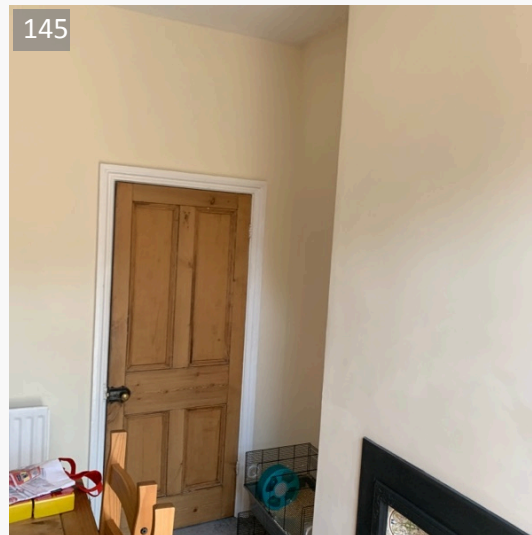
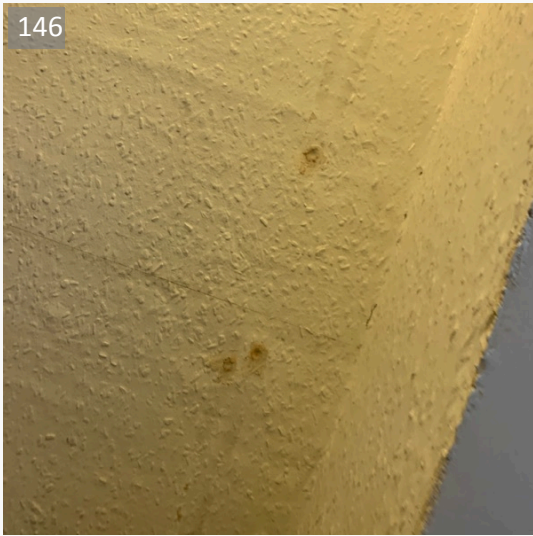
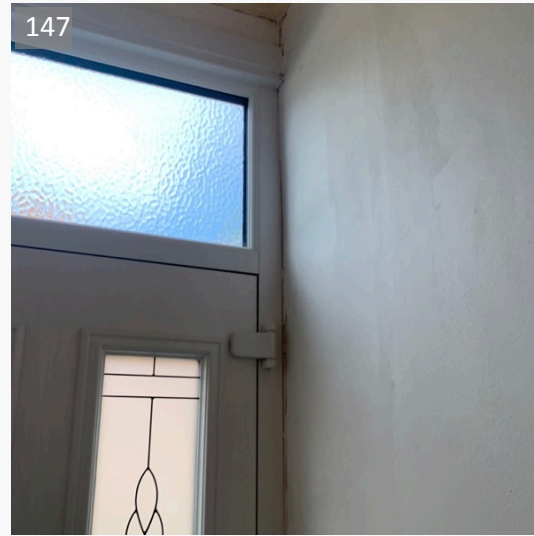
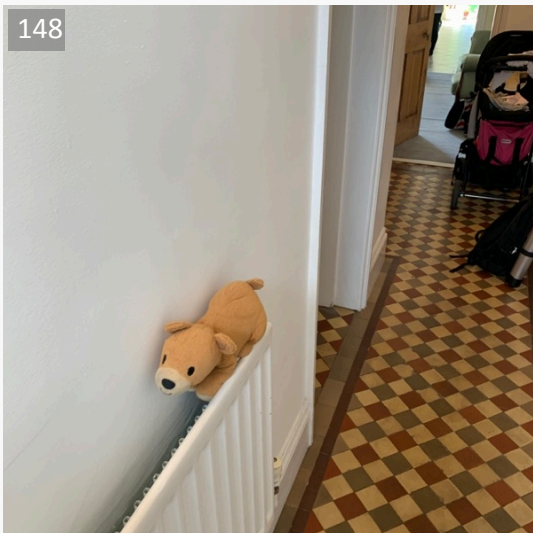
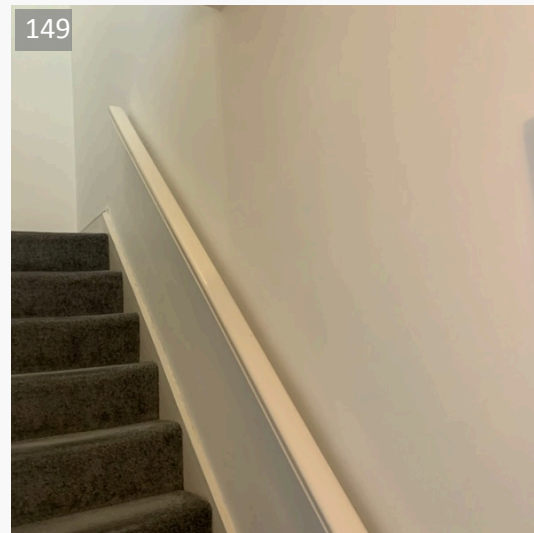
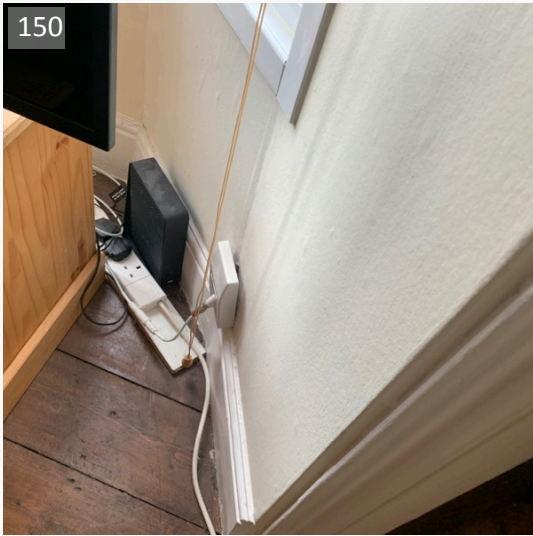
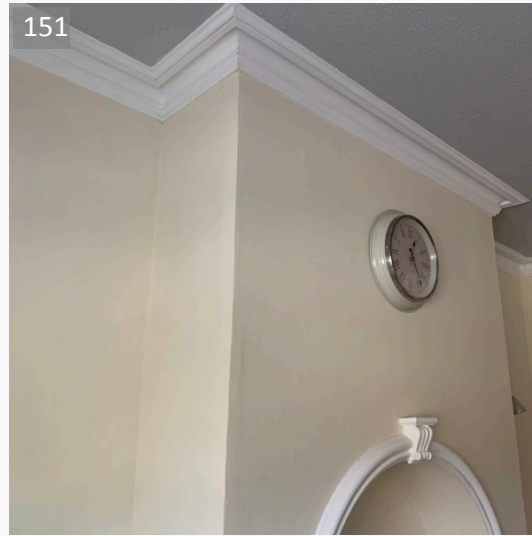
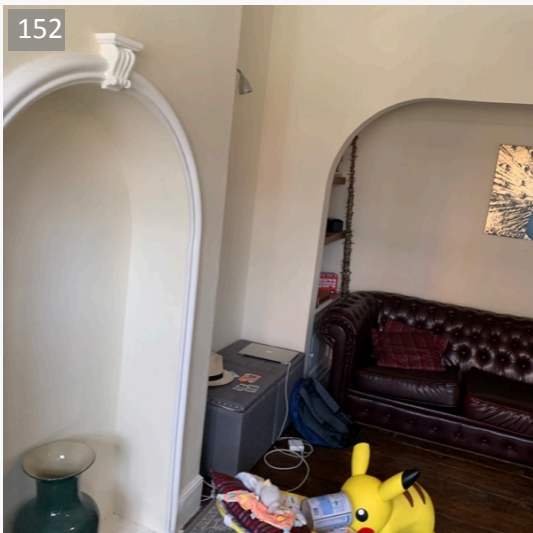
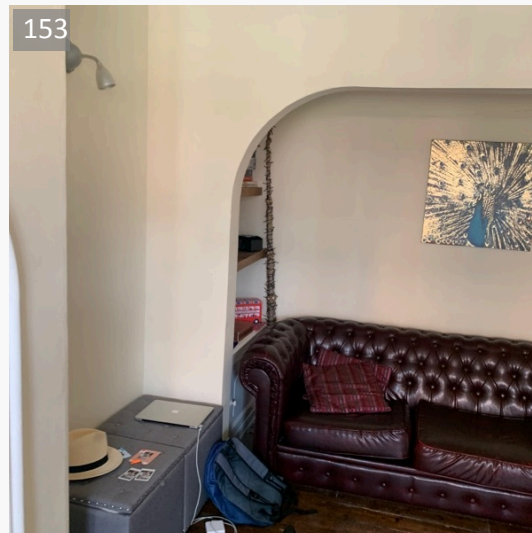
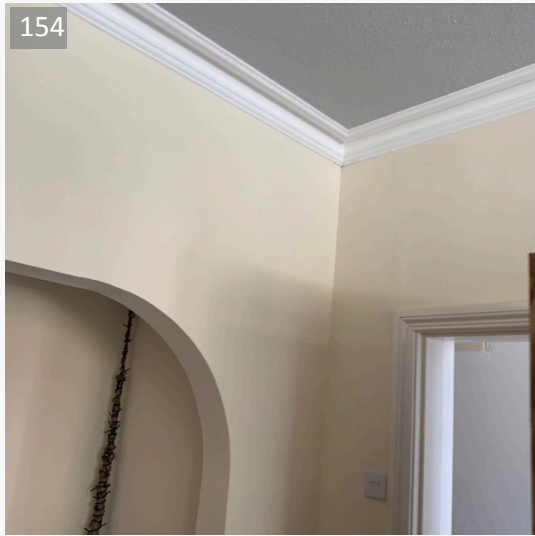
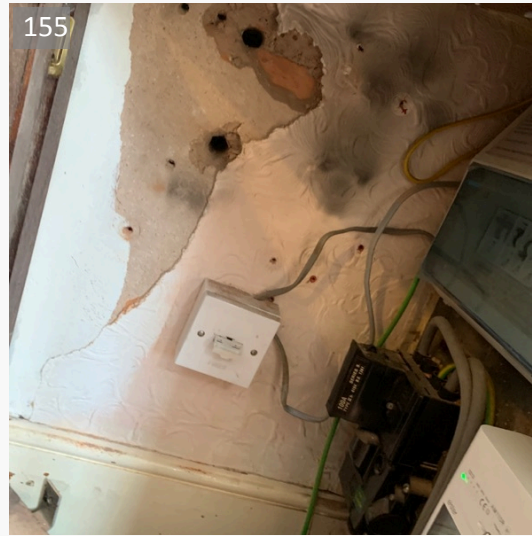
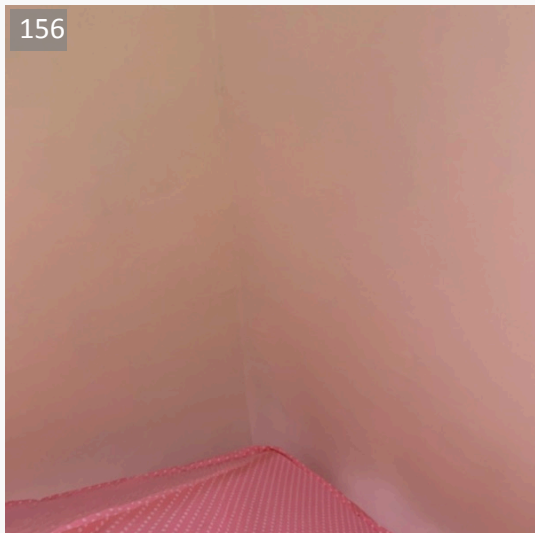
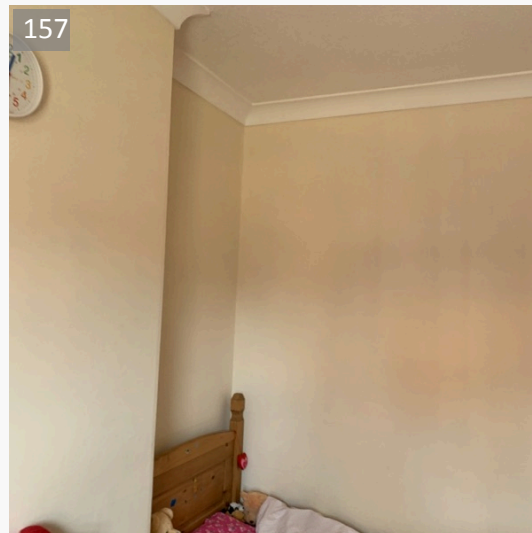
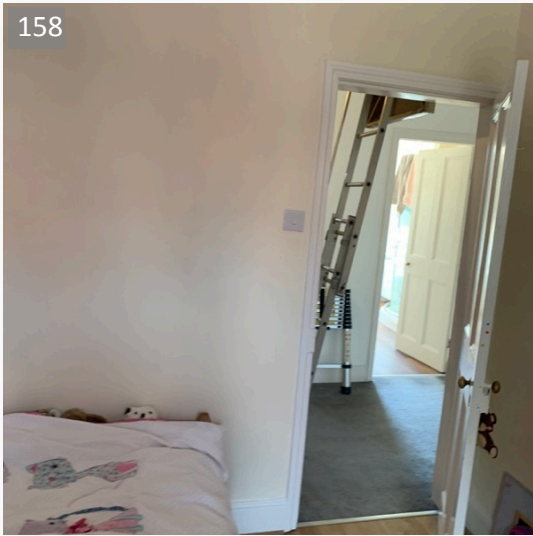
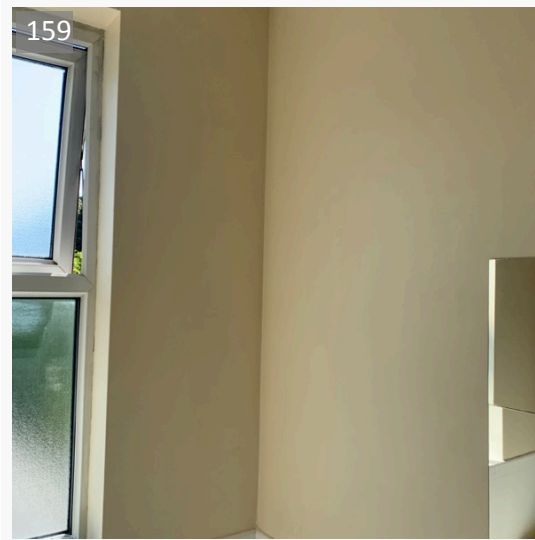
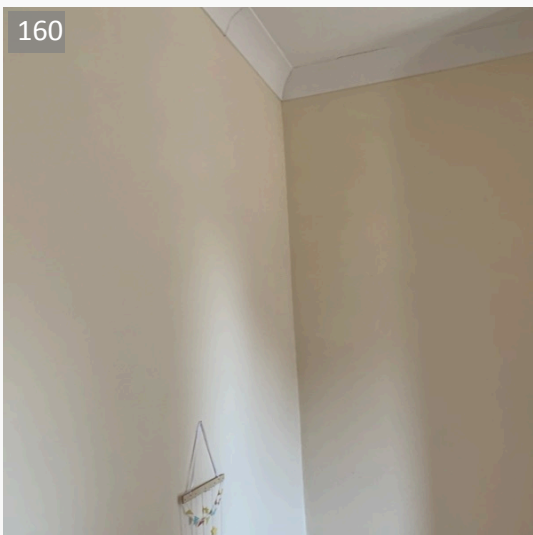
Condition Rating 3

There are elevated damp readings noted to the ground floor internal wall of the subject property these are to be assessed by a damp and timber specialist to provide adequate remediation.

We have inspected the visible uncovered parts of the representative internal partition walls and note that these were found to be free of significant defects or excessive distortions. Areas of minor cracking limited to the finishes should be subject to making good decorative works considering the use of PVA bonding and filler before sanding the dry filler to achieve a flush surface and painting/decorating to match the surrounding area.

Cracks in plaster often occur due to the general ageing of plaster, slight movement between sheets of plasterboard and normal shrinkage over time but this is not considered serious or significant. If the cracks are repaired and filled, they may re-occur from time to time.

Due to the age of the property, you should budget for plaster repairs at the same time as any decoration works as invariably a property of this age will have pockets of live and damaged plaster.

Budget For General Plaster Repair	£ 750.00	Plus VAT
Damp To Be Assessed By Specialist	£ 350.00	Plus VAT
Structural Engineer To Assess Openings Of Kitchen Extension	£ 300.00	Plus VAT
