## RICS Level 3 Building Survey

100 Holland Road  
Sutton Coldfield  
B72 1RE

Client Name:	Abdulrahman Abodarahim
Client Reference:	23-2028
Appointed Surveyor:	Muadh Rehman
Date of Survey:	7th September 2023

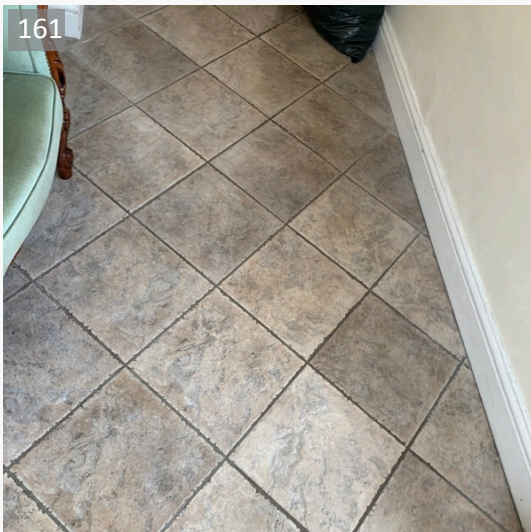
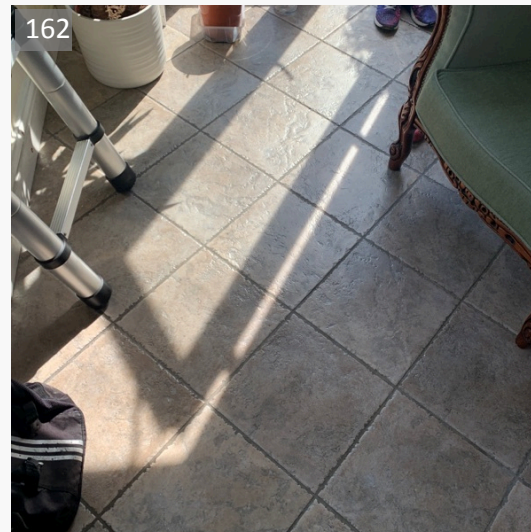
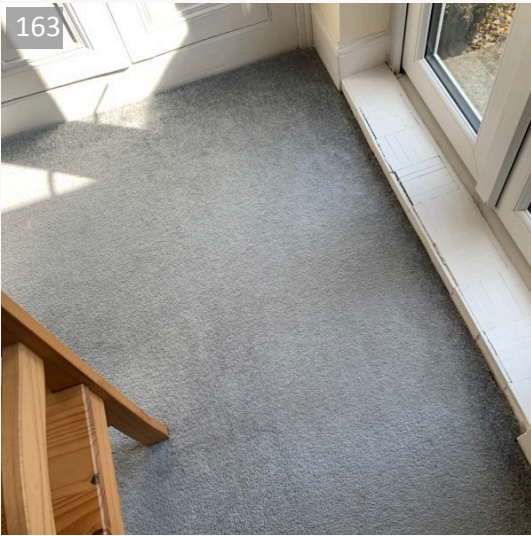
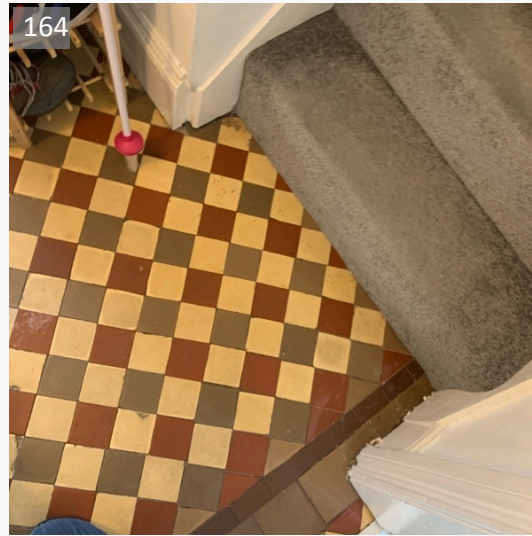
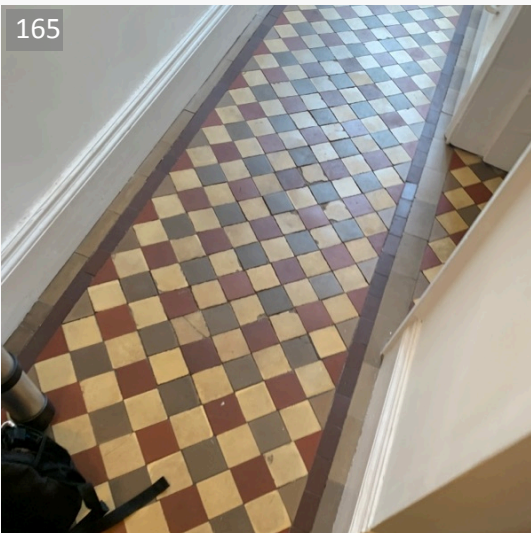
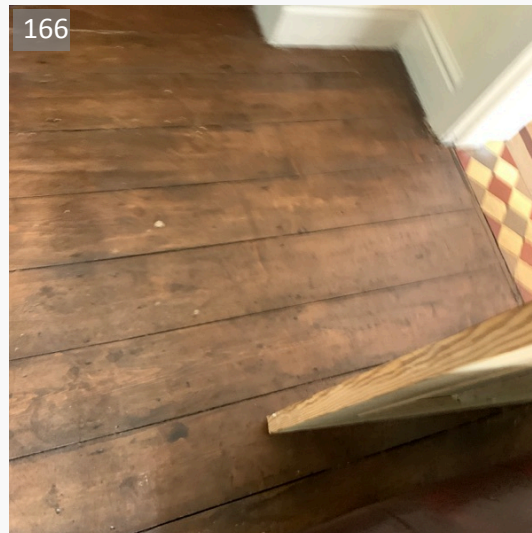
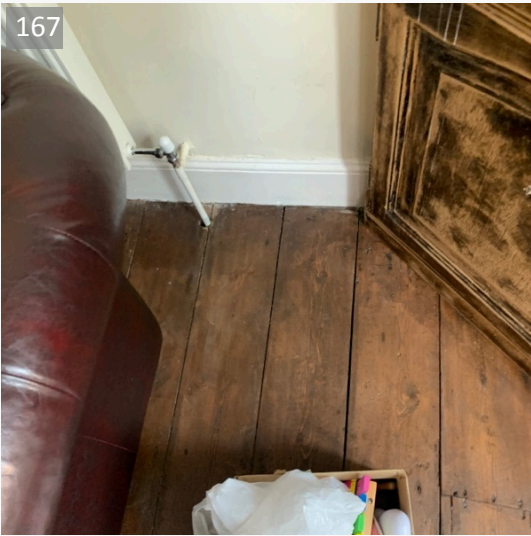
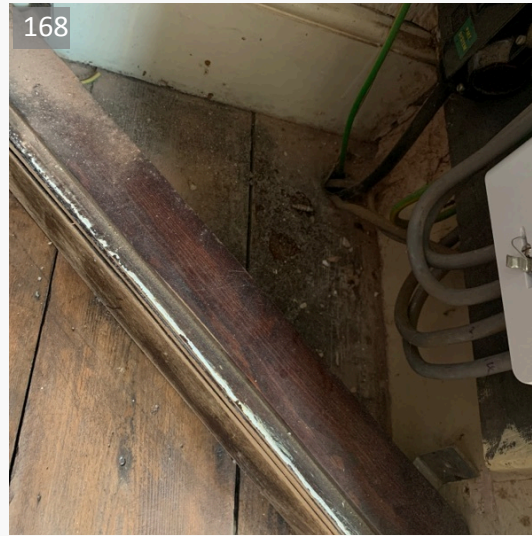
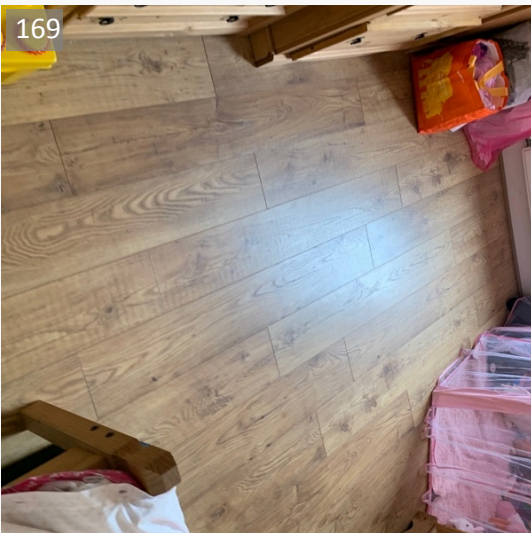
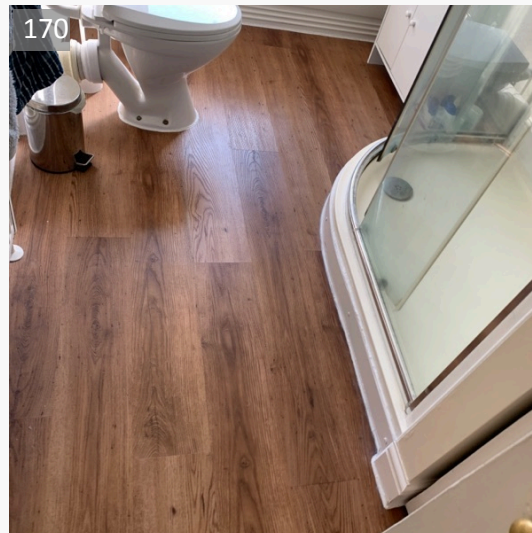
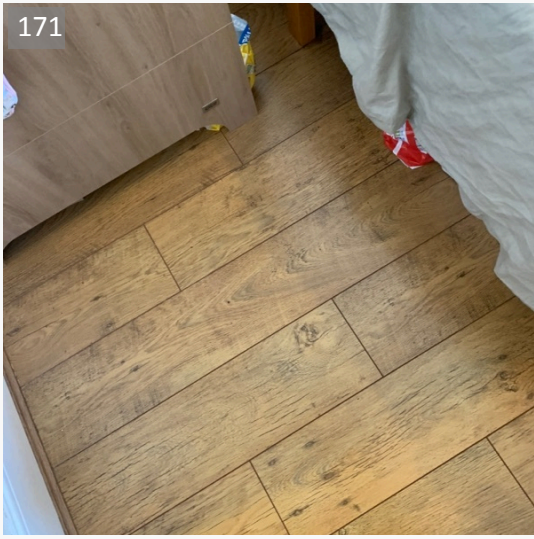
Condition Rating1

The floors are formed of solid concrete construction, which we presume consists of a slab finished with a screed. The floors appeared sound and level underfoot with no evidence of deflection or distortion although our inspection was severely limited due to floor coverings and fittings.

The floor finishes throughout were of fair condition.

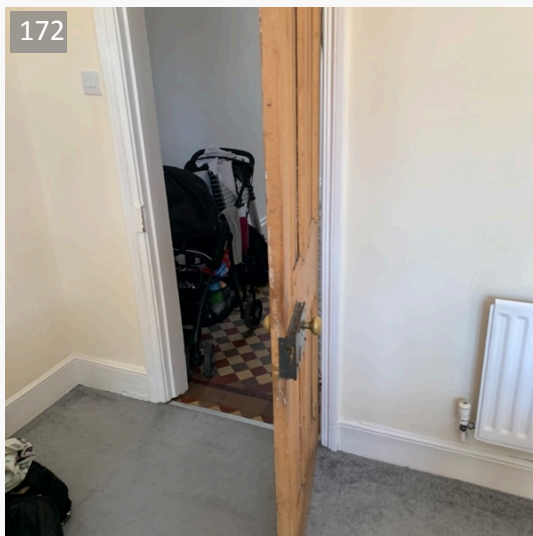
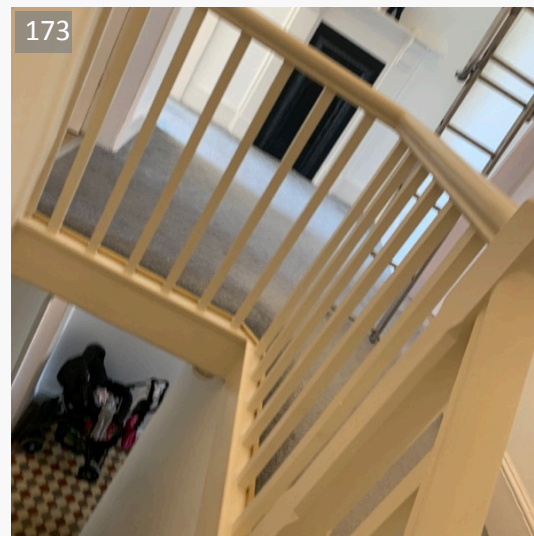
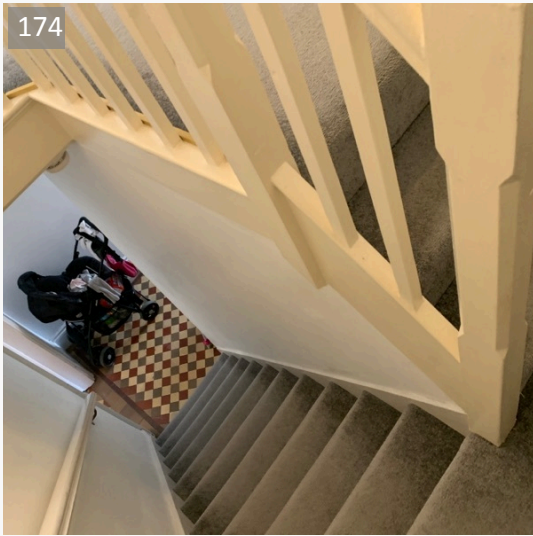
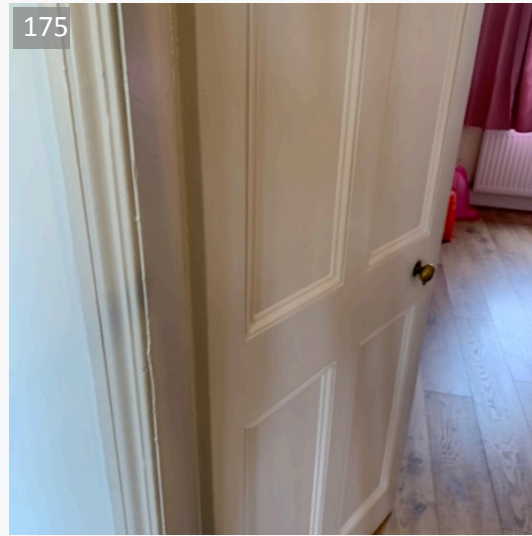
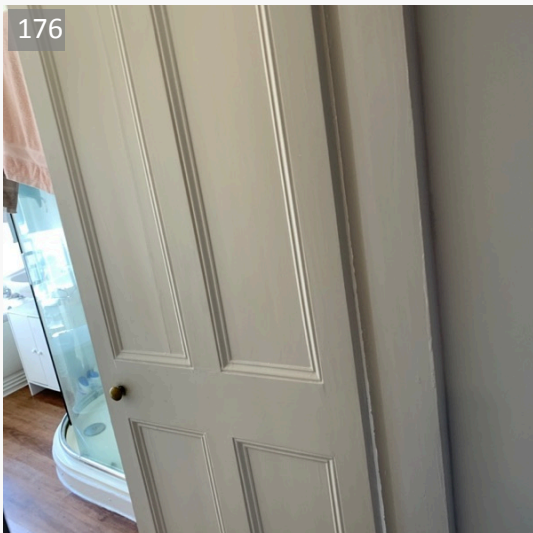
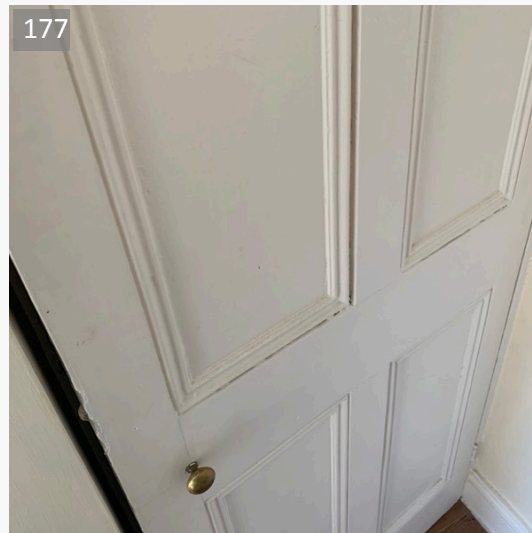
Condition Rating 2

As anticipated, there is some degree of wear, tear and marking to the internal joinery but generally it is in satisfactory condition.

The internal doors are of timber these are in dated condition where the handles were loose which can be tightened. Some handles can be replaced.

No fire doors could be confirmed being fitted to the property, so compliance with “Approved Document Part B - Fire” would be unlikely. At the time of construction/ conversion, this may not have been a requirement but should be noted nonetheless, as it is good practice to fit FD30-rated doors (offering 30minutes of fire protection) to all habitable rooms that open onto the main route(s) of escape. The fire plan for the building should be disclosed and muster/ safe refuge areas identified.

Surrounding the doors and at the base of the walls there are timber architraves, door linings and skirting boards, respectively. These are generally in a robust condition however may benefit from being sanded down and repainted when decorative works are being carried out. We recommend that any small voids are caulked in (deeper dents filled) to ensure that the surfaces remain flush.

The main staircase comprises of a series of straight flights and winders to the landing areas. The staircase comprises of timber framing elements; these appear to be adequately framed and wedged together in the first instance, with no significant buckling underfoot when traversed.

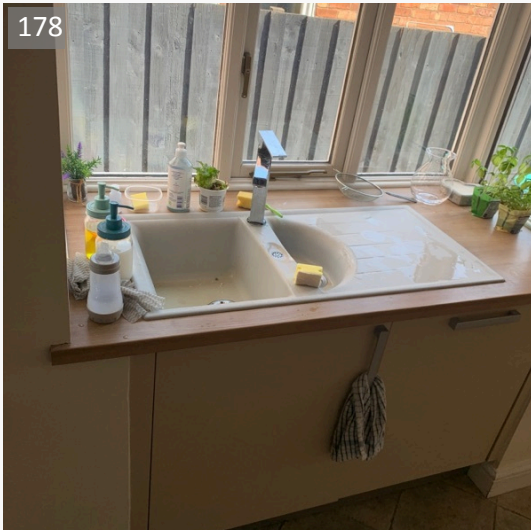
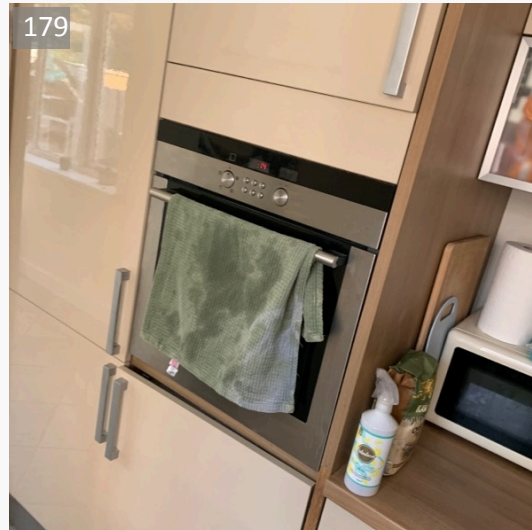
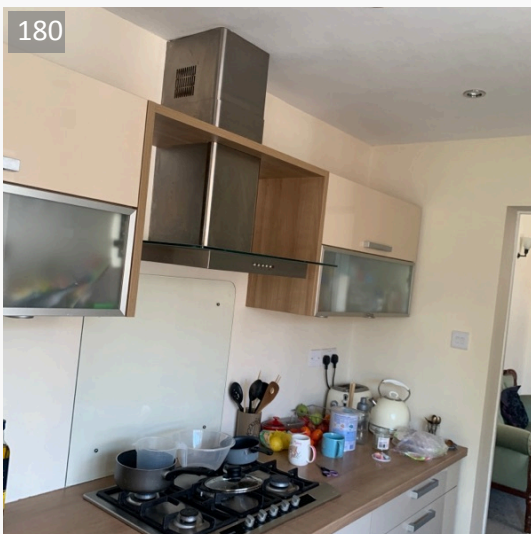
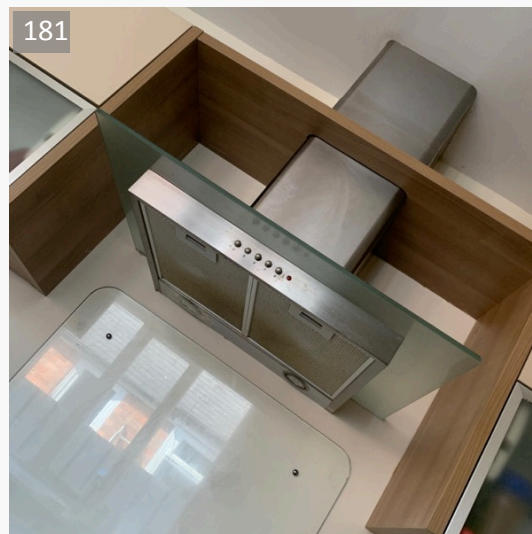
Condition Rating 2

The kitchen has been fitted with modern floor and wall cupboards, a sink and drainer and all are broadly satisfactory for the preparation and storage of food. The tap is found with leaks that is to be amended by a tradesperson.

It is recommended that the mastic (sealant) between the worktop junctions and the splashback is periodically raked out to prevent water ingress to the underside of the worksurface and carcass below and mould build up.

Leak To Tap To Be Amended	£ 50.00	Plus VAT
---------------------------	---------	----------

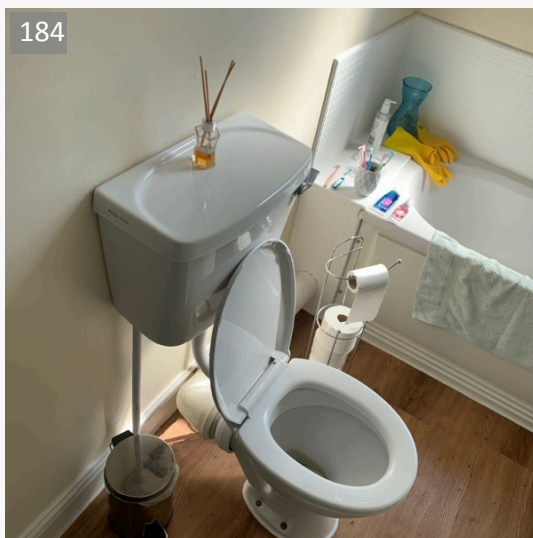
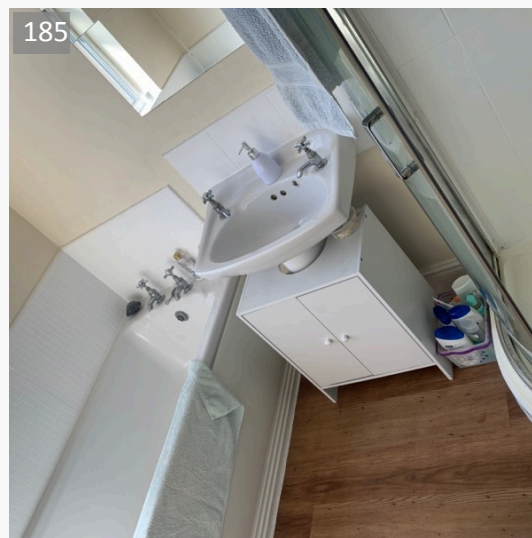
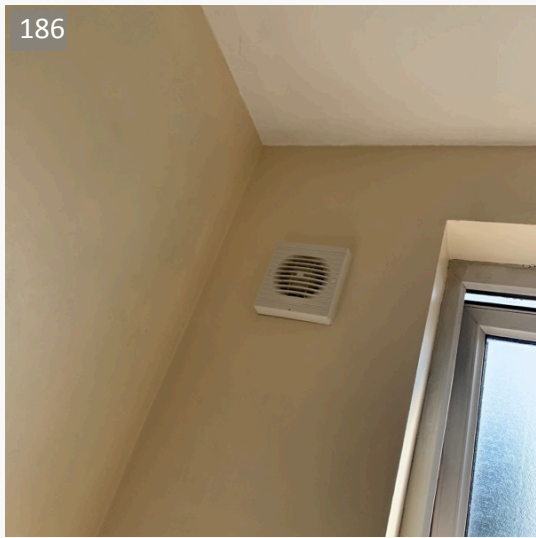
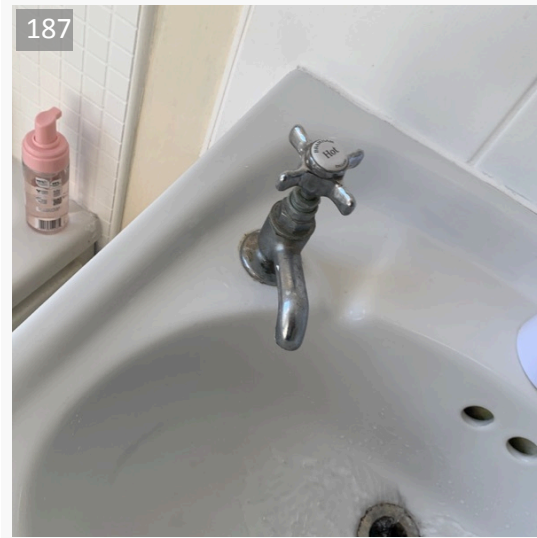
The sink and bathtub taps were found tight where these are to be loosened.

Showers over the ends of baths and shower trays/cubicles are very susceptible to leakage and should be checked regularly and resealed as found necessary. The seals around all of the bathroom fittings should be renewed regularly to prevent seepage and damp occurring.

As a measure of good practice and prudence, It is recommended that you periodically rake out and replenish the flexible mastic anti-fungal silicone sealant local to the perimeter of the sanitary fittings and sanitary floor covering areas to ensure water tightness and prevent water ingress into the sub floor to prevent timber rot.

It is essential that any wall tiling grouting is kept in good order to prevent moisture penetration from wet areas, such as shower cubicles and baths, so moisture cannot pass through the tiled wall surfaces to the other side. It is also important that all mastic seals and alike between sanitary appliances such as shower trays and bath edges are maintained. This is to prevent shower/bath overspill from penetrating into the voids beneath and affecting other hidden timber structures over time.

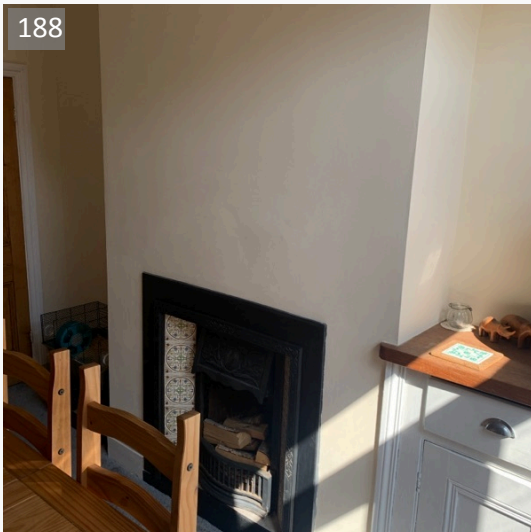
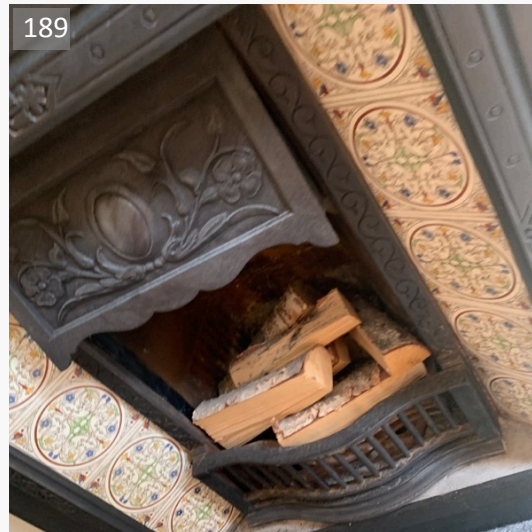
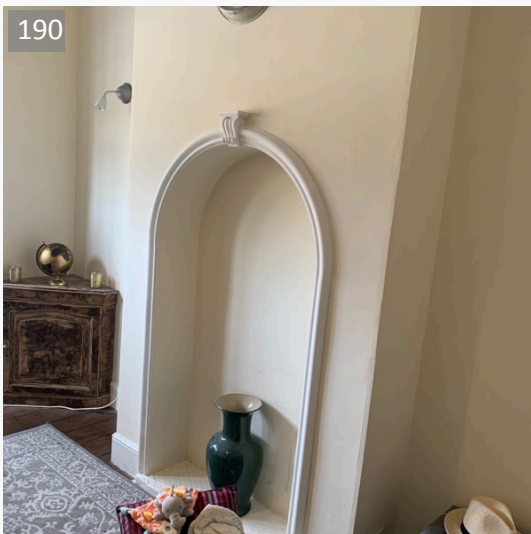
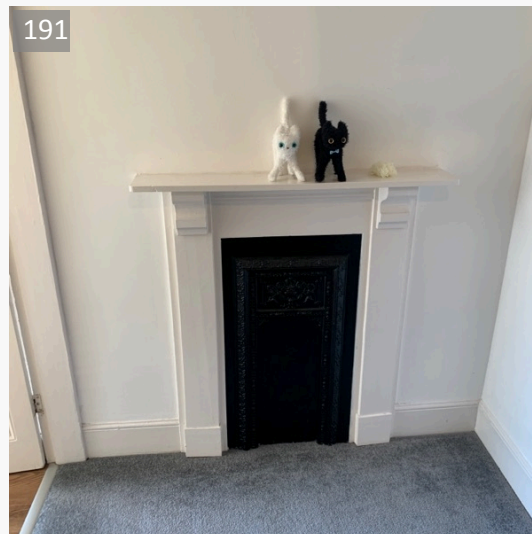
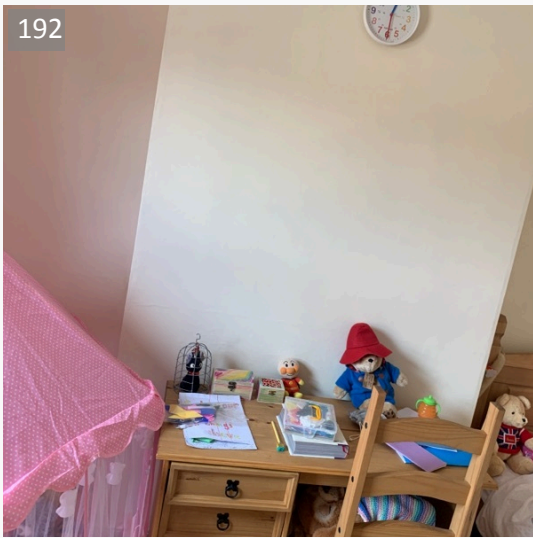
A fireplace is set to the rear reception and first floor landing.

If you propose to use flues for open fires or appliances, they first must be swept, the condition of the linings confirmed and a smoke test carried out by a NACS-approved chimney sweep. It is not possible to indicate the condition of flues or the presence of flue liners, or if there is adequate surface area and volume for ventilation of exhaust gases. No assumption has been made as to the practicality of using the chimneys. With a property of this age soft lime mortar was used in the construction of the flue and you should budget for possible relining of the flues with a proprietary flue lining system. Lack of satisfactory flue linings can lead to deterioration in chimney stack(s)/breast(s). This can cause failure in masonry/plaster etc and can also lead to the escape of sparks and fumes, with the resultant safety/fire hazard.

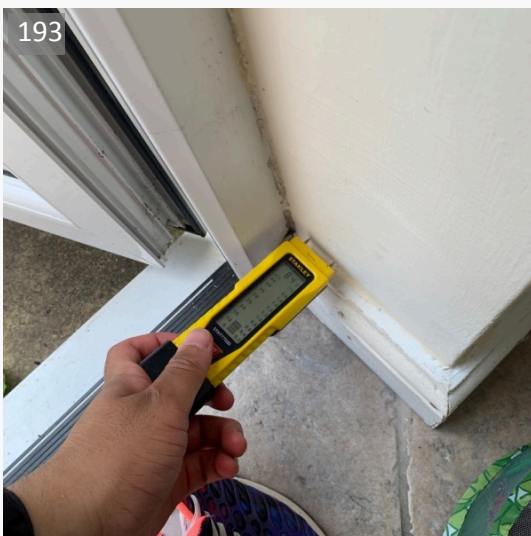
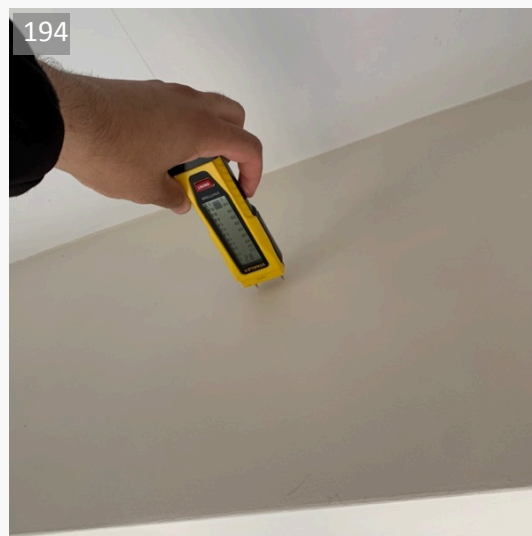
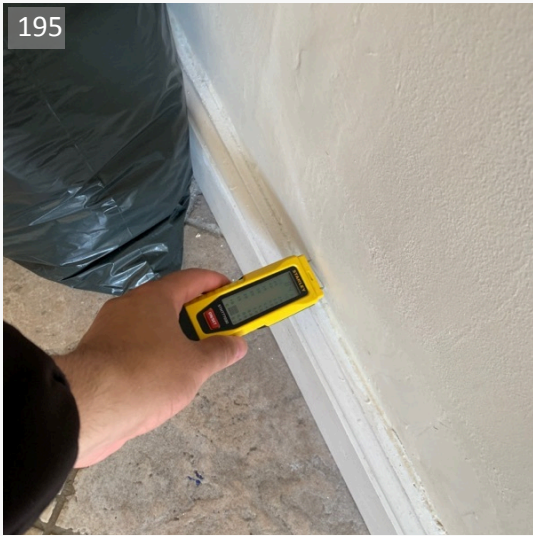
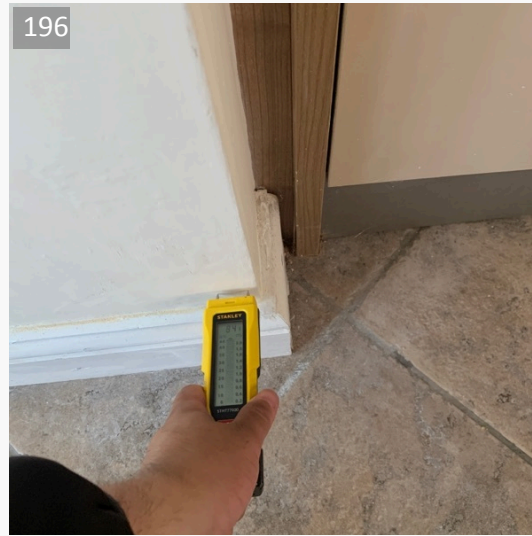
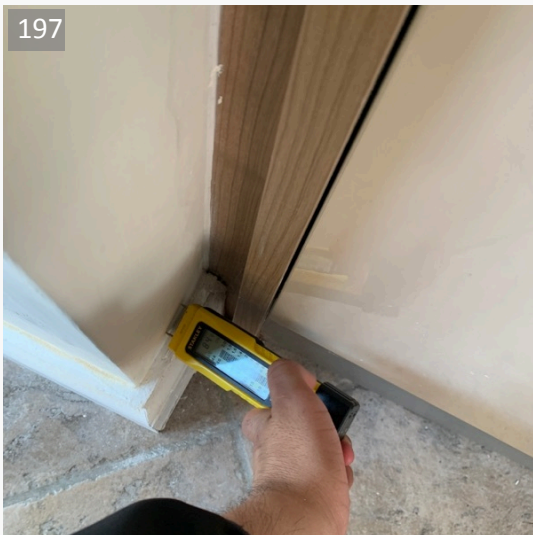
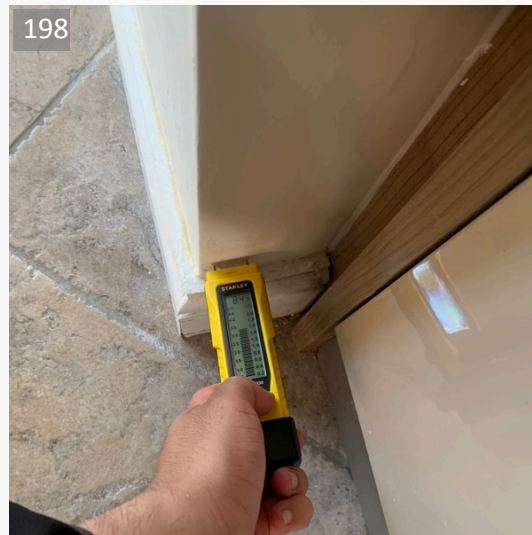
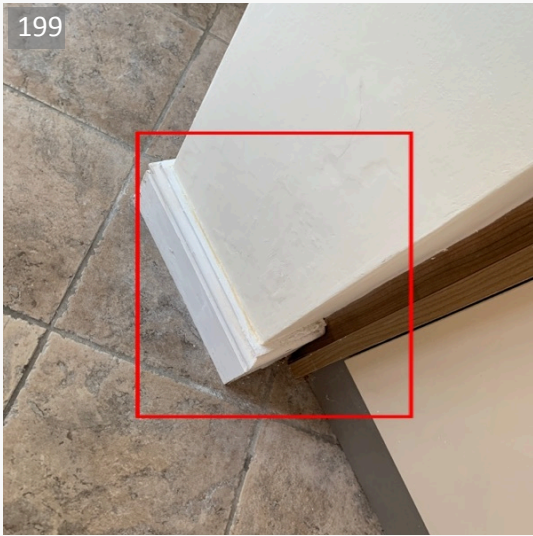
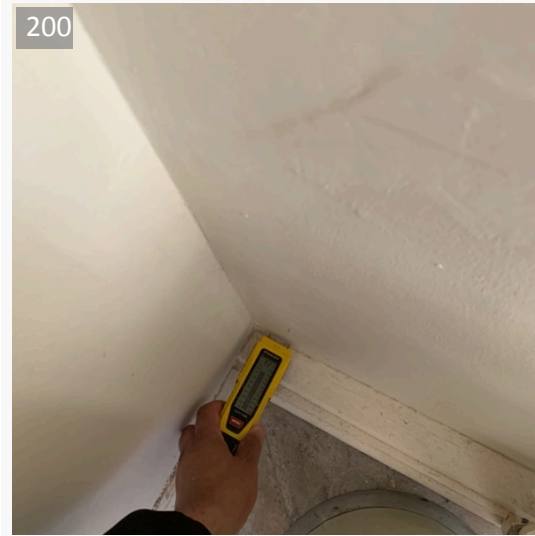
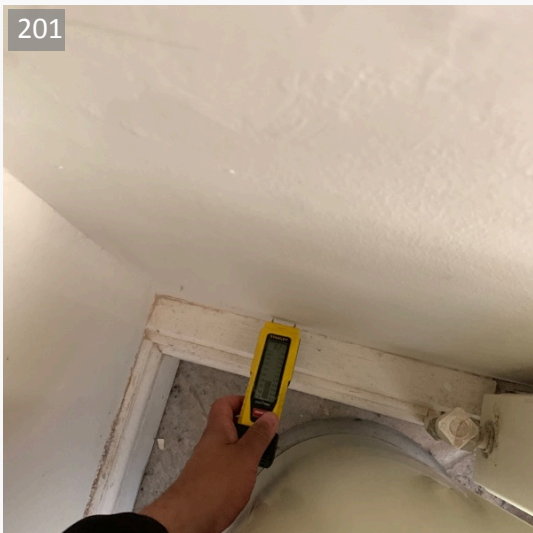
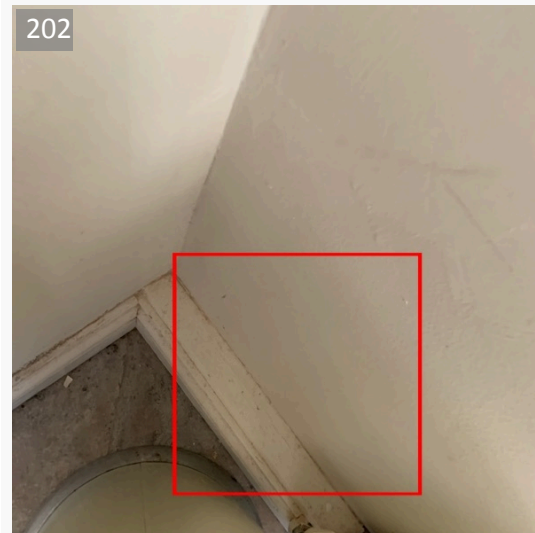
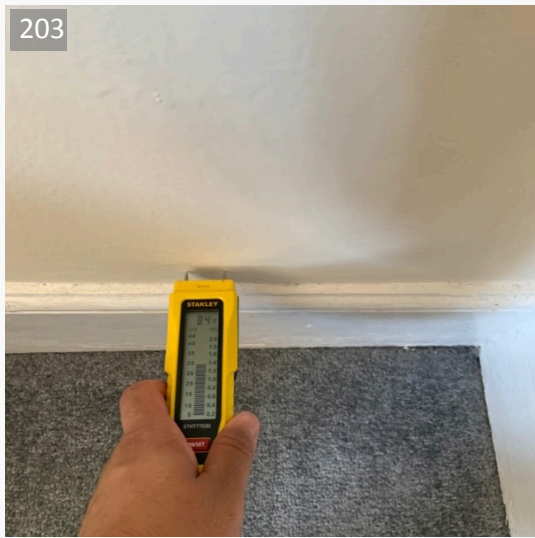
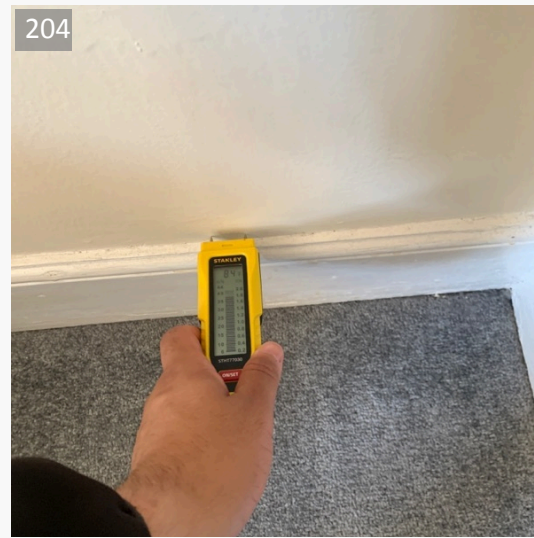
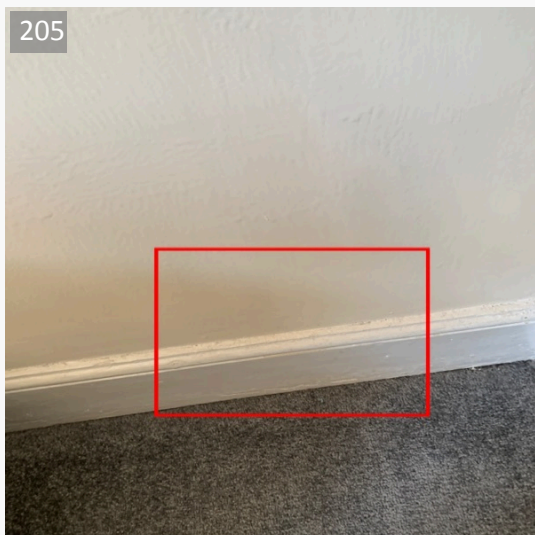
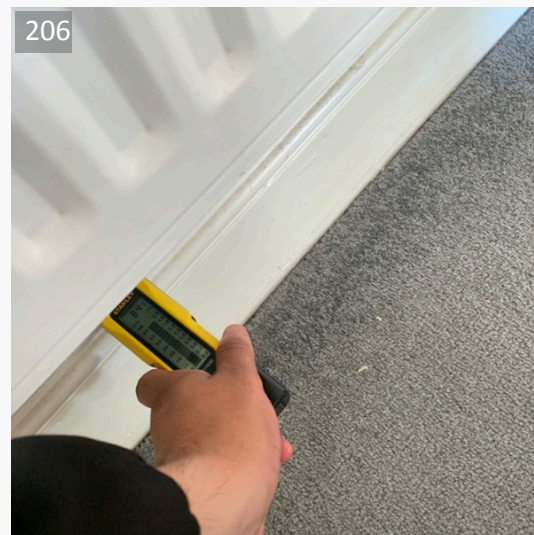
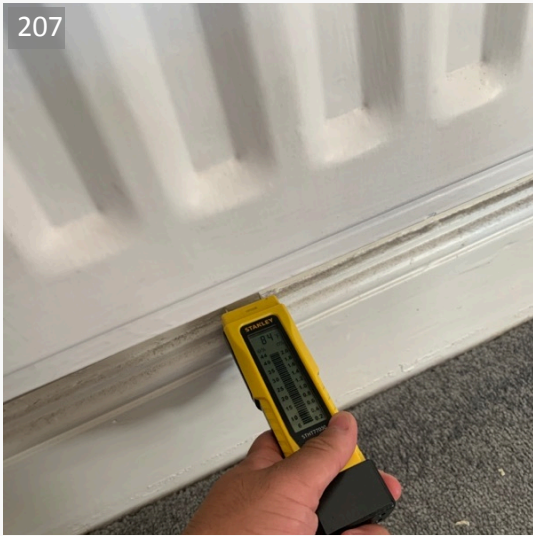
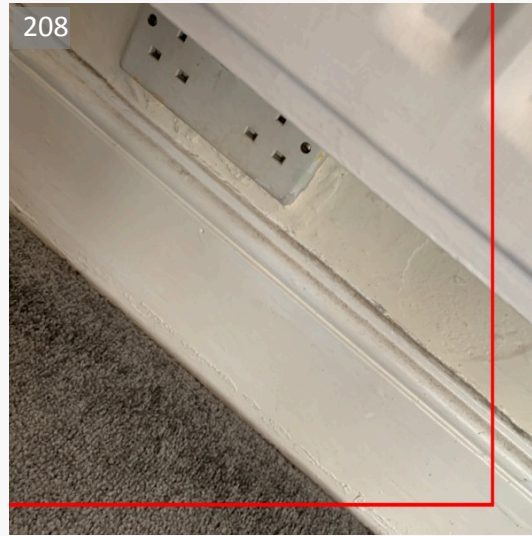
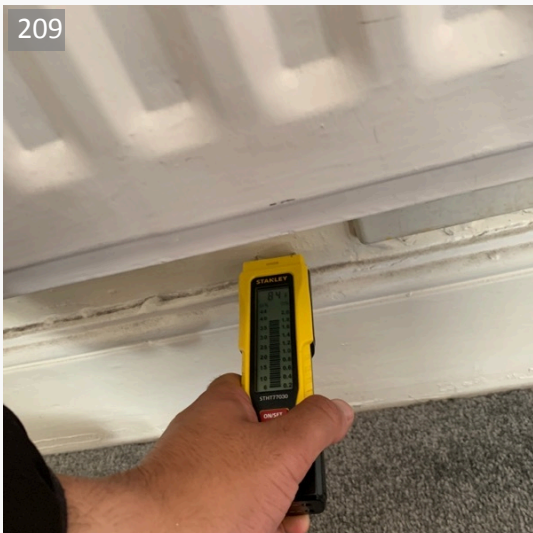
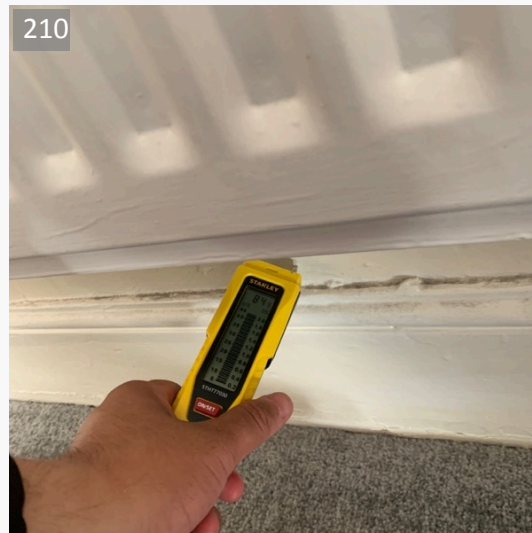
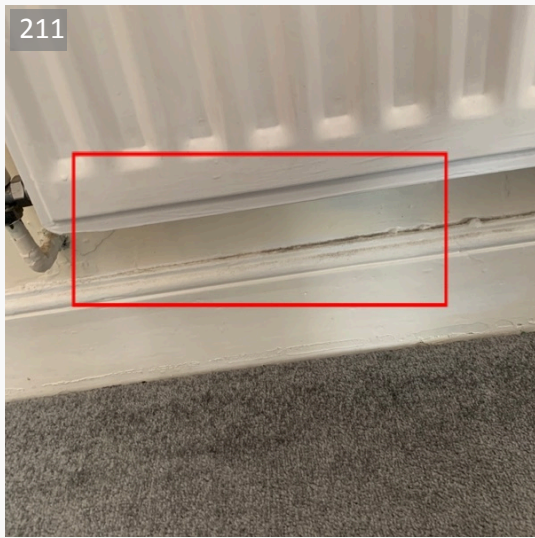
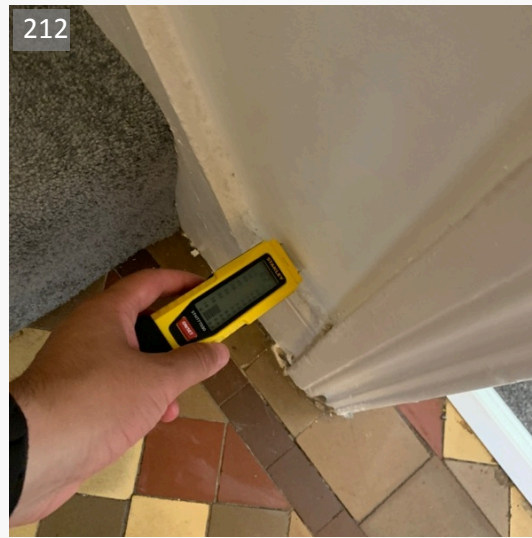
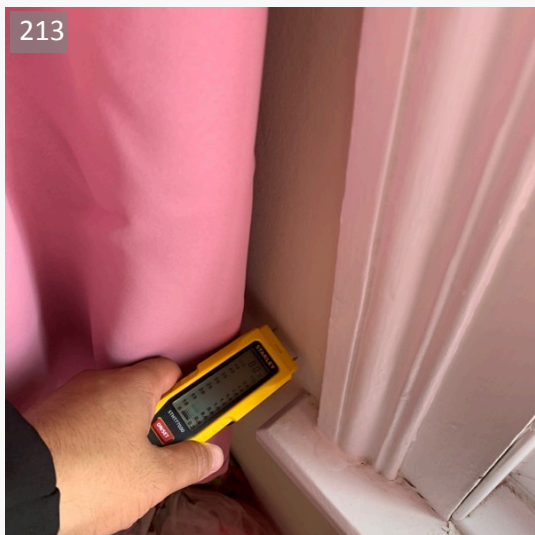
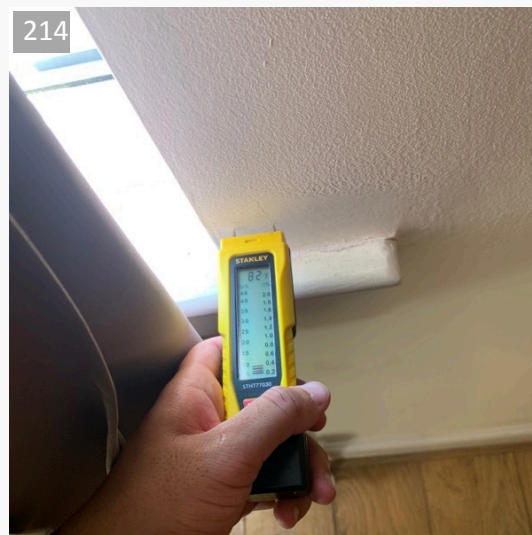
We noted significant dampness to the internal areas of the property at the time of our inspection.

At the ground floor to the protruding wall within the kitchen and also the wall at the flank where it meets the rear reception wall. Further elevated readings are noted to the reception room below the radiator and to the party wall. A damp and timber specialist is to further investigate to provided adequate remediation.

To rectify rising damp, a chemical can be injected into your affected walls which will create a barrier to prevent more ground moisture from being soaked up. To do this, you'll need to bring in a damp specialist who will first remove the plaster from the lower half of your walls before injecting the chemical. Once this is done, your walls will be replastered leaving you free to redecorate.

Damp Specialist To Further Investigate Damp Areas (Budget For Repair £5000)	£ 350.00	Plus VAT
---	----------	----------

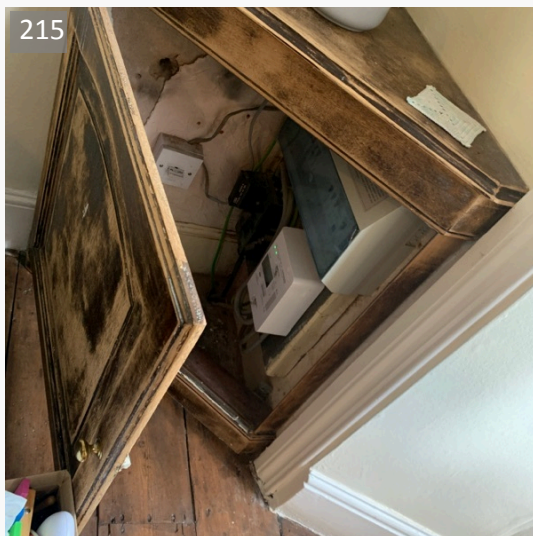
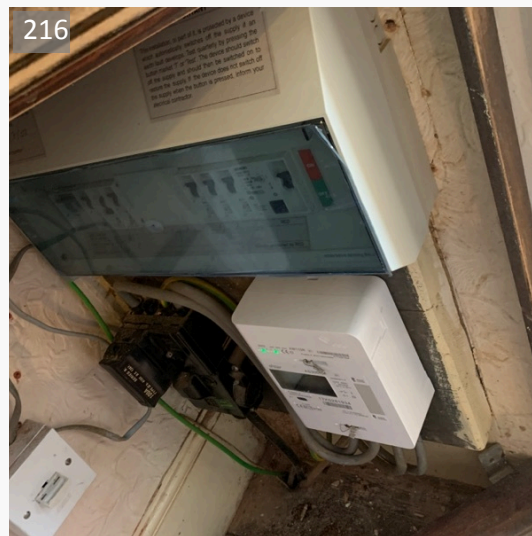
In the absence of certification for complete testing, surveyors have to give designation three to this item.

All electrical wiring, installations, fixtures and fittings should be inspected and tested by an electrical engineer registered under a relevant competent person scheme listed on the Government's Competent Person Scheme website.

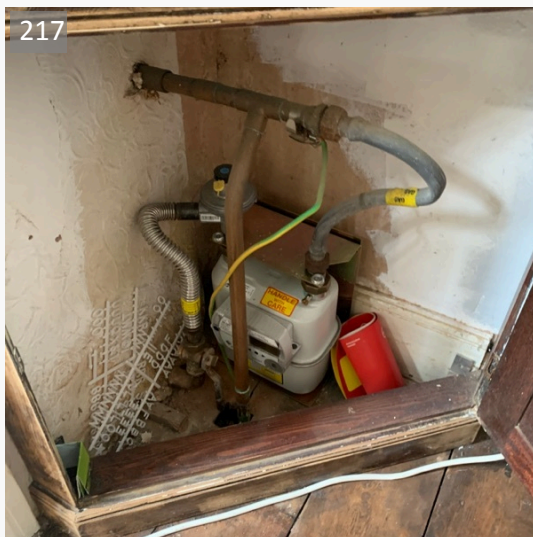
No obvious problems were noted No gas smells were noted around the gas appliances but their acceptability in terms of condition, performance and safety can only be confirmed by professional testing. Carbon monoxide gas can be given off by poorly ventilated appliances. This is colourless and odourless and can be fatal to human health.

All gas installations and associated fittings should be inspected and tested by a Gas Safe registered engineer. The Gas Safe Register recommends that homebuyers should have gas fires, boilers, ovens and hobs checked by a Gas Safe registered engineer before purchasing a property.

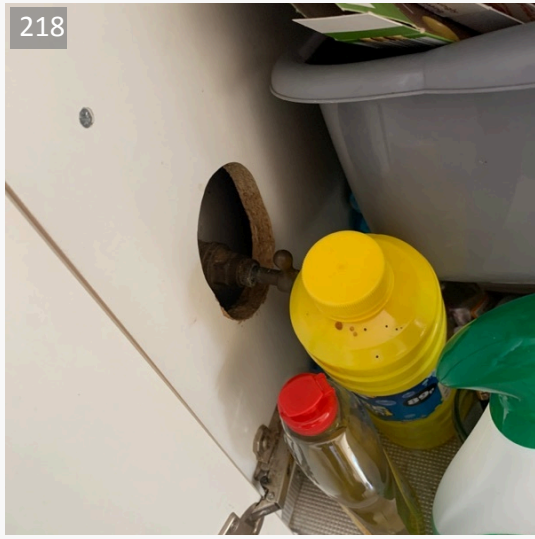
The water supply and plumbing system generally appeared in satisfactory condition.

We recommend testing of the supply suitability and water pressure is undertaken by a competent specialist prior to purchase.

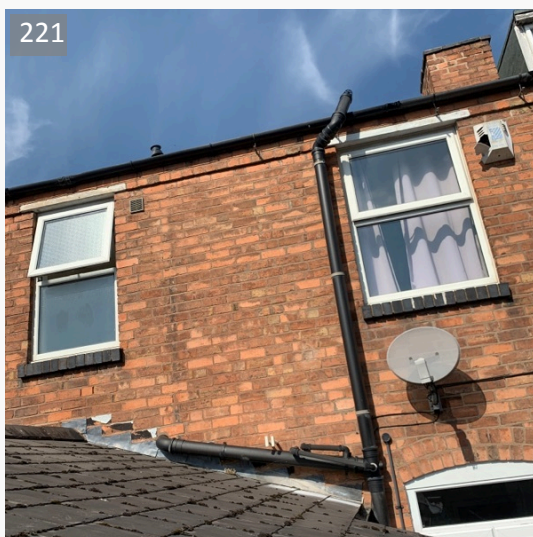
The underground drainage is most likely formed of the original vitreous clay pipework and likely may run under or adjacent to the property, which could cause potential issues. As a prudent measure, it is recommended that you arrange for the underground drainage to be surveyed with a CCTV camera by a specialist, in order to report on the condition and to rule out any potentially leaking underground drainage.

Fittings were run and flushed and there was no obvious evidence of back up or blockage.

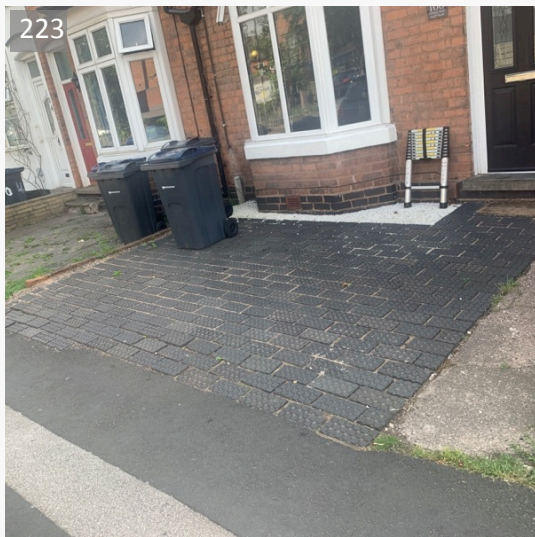
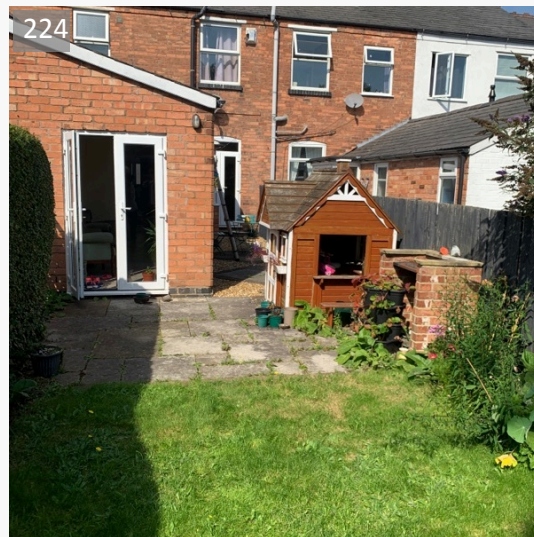
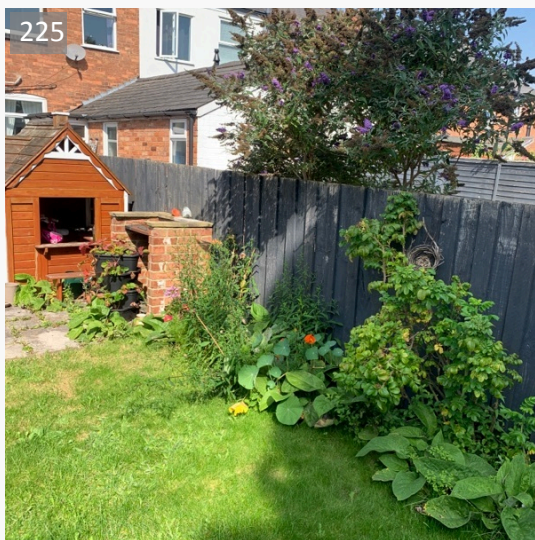
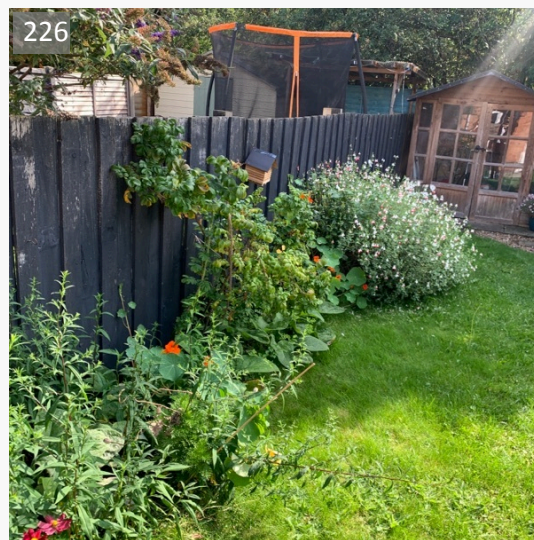
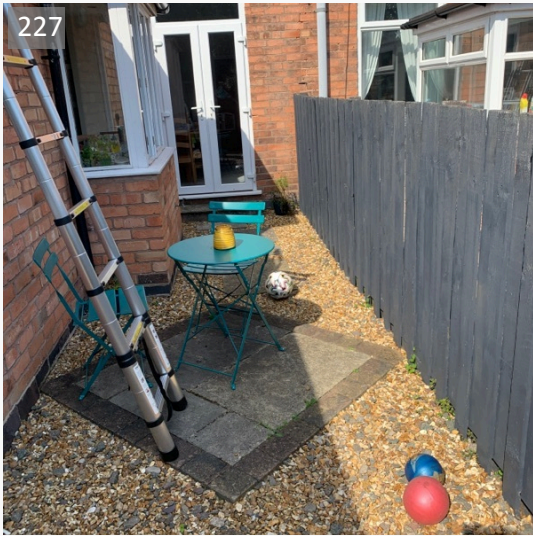
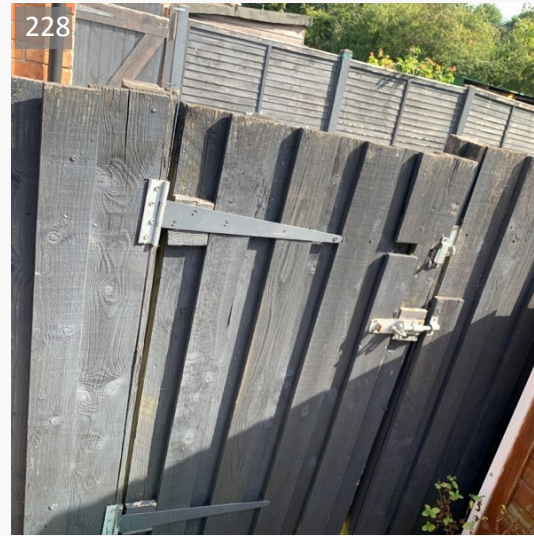
The frontage comprises of block majority block paves with shingles around the bay. General maintenance is recommended. There are no borders to the neighbouring property.

The rear garden comprises of shingles laid with concrete slabs from the rear reception, further slabs are noted from the kitchen entry at the patio with the remaining of laid lawn and additional shingles to the rear.

At the borders are timber fences and hedges. These remain robust. A further timber gate allows access through the neighbouring properties. The boundaries should be established.

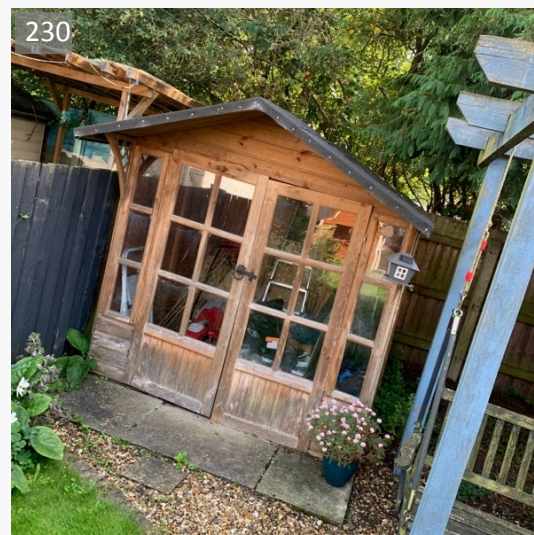
There is a timber storage shed to the rear garden in dated condition.

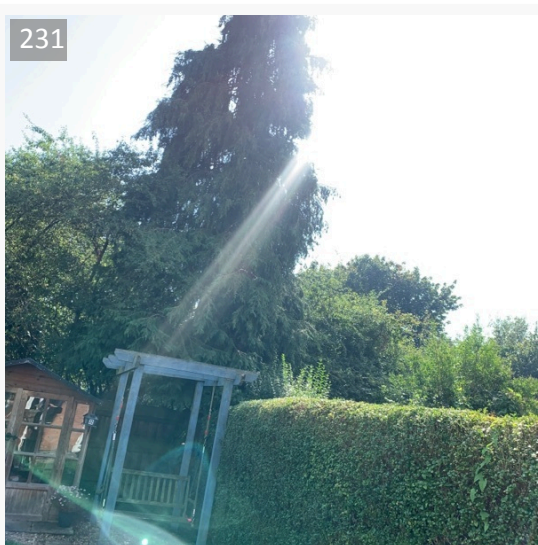
We recommend enquiries be made with the freeholder of neighbouring grounds as to whether there are any ongoing control measures, such as pollarding and pruning, to control the heights of surrounding trees and thus to control their influence on the moisture content of the surrounding soil, offering anchorage to the foundations of nearby buildings.

This is in order to control seasonal ground movement to within acceptable thresholds, to mitigate any excessive ground movement issues such as subsidence. If trees and shrubs in close proximity to a building are left to grow unabated and tall enough, they could potentially cause problems for a historic building built upon a shrinkable clay substrate.
