**CARBON SIX
LETTINGS**

Sample Check In Report

123 Sample Road
City
Postcode

Company	C6 Lettings
Date of Inspection	24/02/2021
Prepared by	C6 Lettings
Inspected By	Mr. Inspector
Agent	Ms. Agent
Adults	2

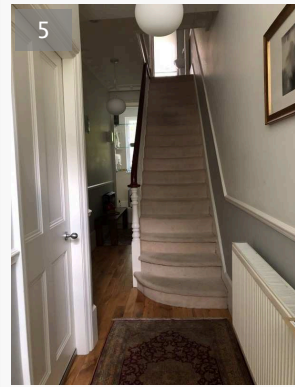
Entry hallway and stairs all appear in reasonable condition with some minor scuff marks on the walls, and carpet showing wear and tear.

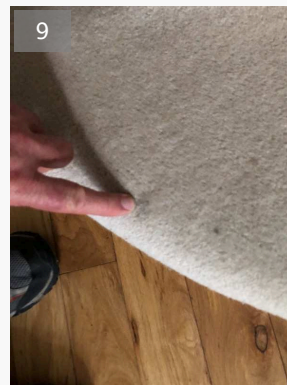
Minor stains on all steps up to the 2nd floor.

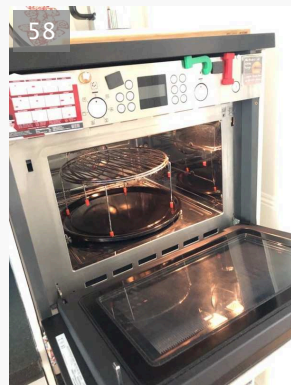
Microwave functions, in very good condition.
24/02/2021 12:44 (GMT)
at 51.57141870467363°,
-0.1298235630298187°

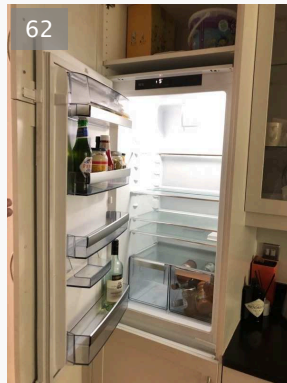
Refrigerator appears in good functional condition, no obvious blemishes.

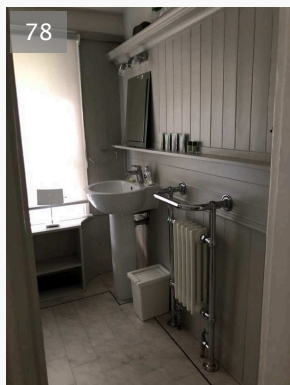
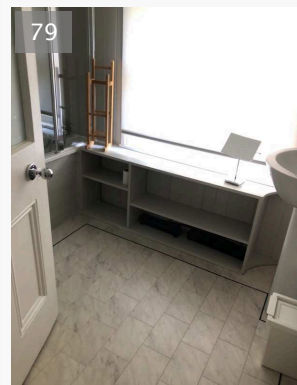
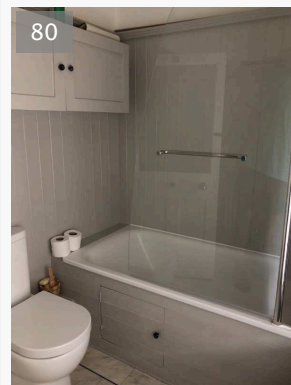
Generally bathroom in serviceable condition. Clean with some loose wear and tear visible on the floor, walls, doors, and plumbing fixtures.

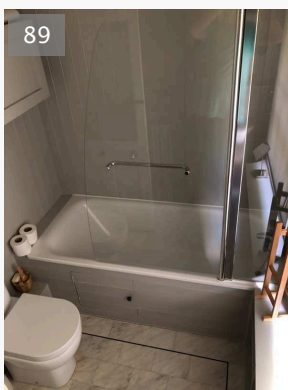
Damaged

Photo with caption and flag used to bring attention to ceiling damage.

Toilet is leaking. Note stains on floors.

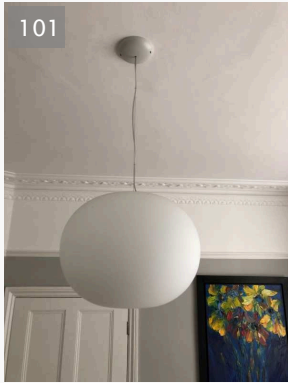
Dusty on top of light fixture.

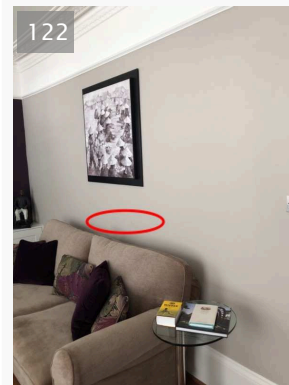
Marked-up photo showing scuff marks on wall.
24/02/2021 14:13 (GMT)
at 51.57143068142398°, -0.1297358933491194°

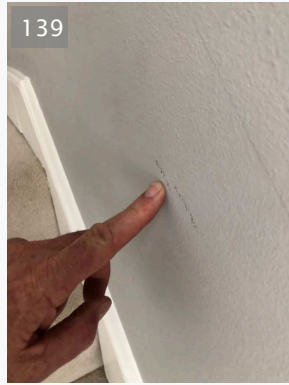
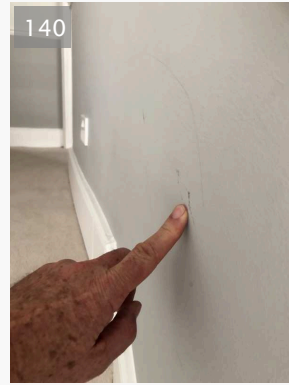
Minor scuff marks on the walls.

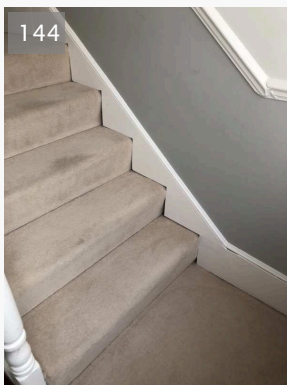
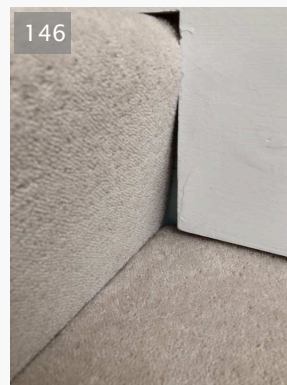
**Poorly fitted baseboard
from landing to 3rd floor.**
24/02/2021 14:20 (GMT)
at 51.57158432471942°,
-0.1296938362342097°

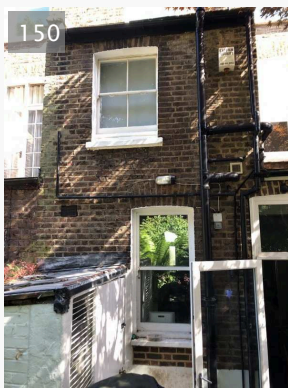
Exterior brickwork and
grout joints are in good
serviceable condition.

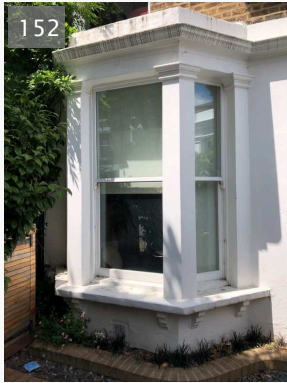
Ground floor has the bay windows. These are wood sash windows, appear to be in good serviceable condition.

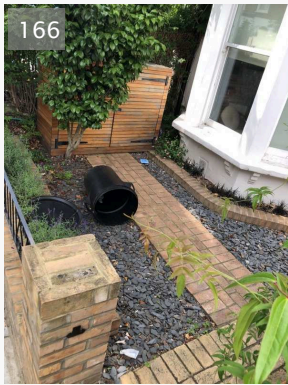
Brick footpath with stone infill and planters adjacent to house and fence. Generally in good condition with some loose debris left lying around.

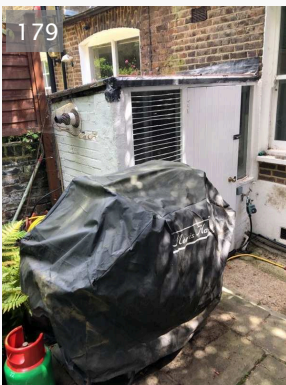
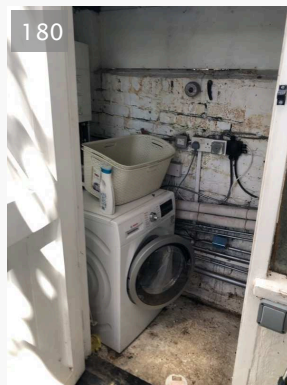
Outside Storage

Worn

The condition slider has been set to worn to bring attention to the outside storage.

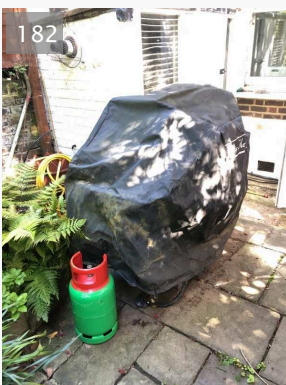
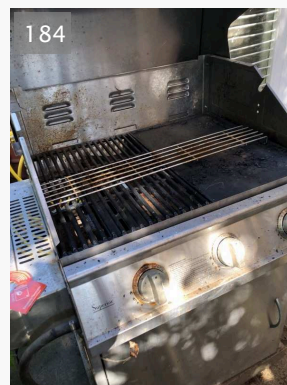
BBQ

Worn

The condition slider has been set to worn to bring attention to the BBQ.
